Access Compliance Report
Public Rights-of-Way
(Curb Ramps)

Intersection ID: 27190	**Main Street: BALLANTYNE_COMMONS_PY Cross Street: WOODVIEW_CR**	**Location: NW**
ADA ID: 2D17B8288E8C	**Ramp Type: BlendTrans2** **Initial Pass/Fail: Fail** **Overall Compliance: No**	**Severity Score: 35**

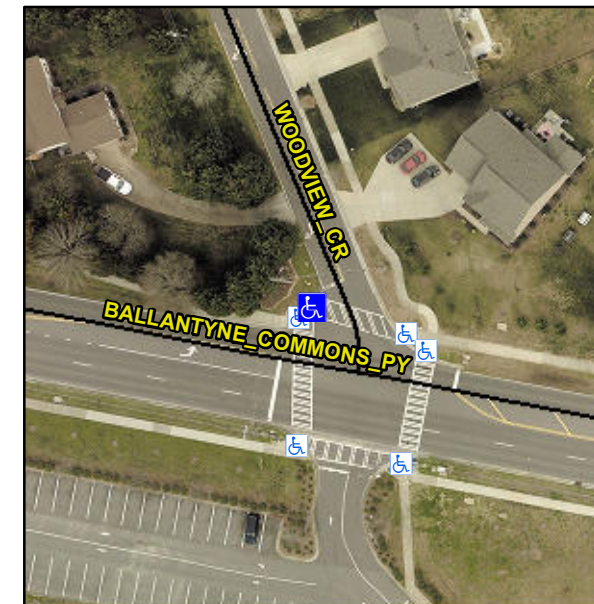
Not Found, R304.5.1

Compliance	Description	Data	Compliance	Description	Data
N/A	Ramp Length (in)	78.0	Yes	BlendTrans Slope (%)	2.7
No	Ramp Width (in)	28.0	Yes	BlendTrans XSlope (%)	1.1
N/A	Flare Type LT	N/A	N/A	Flare Type RT	N/A
N/A	Flare Slope LT (%)	N/A	N/A	Flare Slope RT (%)	N/A
N/A	Flare Traversable LT?	N/A	N/A	Flare Traversable RT?	N/A
N/A	Landing Length (in)	N/A	N/A	DWS Provided?	N/A
N/A	Landing Width (in)	N/A	N/A	DWS Contrast?	N/A
N/A	Landing Slope (%)	N/A	N/A	DWS Length (in)	N/A
N/A	Landing X Slope (%)	N/A	N/A	DWS Full Width?	N/A
N/A	Landing Curb? (Y/N)	N/A	N/A	DWS Offset (in)	N/A
N/A	Shared Landing?	N/A			
N/A	Gutter Ponding?	N/A	N/A	Gutter Slope (%)	N/A
N/A	Gutter Lip Ht (in)	N/A	N/A	Gutter X Slope (%)	N/A
N/A	Painted X Walk1?	Yes	N/A	Painted X Walk2?	N/A
	X Walk 1 Direction	To E		X Walk 2 Direction	N/A
	X Walk 1 Width (in)	110.0		X Walk 2 Width (in)	N/A
	X Walk 1 Slope (%)	4.3		X Walk 2 Slope (%)	N/A
	X Walk 1 X Slope (%)	1.0		X Walk 2 X Slope (%)	N/A

N/A	Ramp inside XWalk1?	Yes	N/A	Ramp inside XWalk2?	N/A
	Road Slope (%)	1.0		Clear Space?	N/A
	Road X Slope (%)	4.3	N/A	Clear Space to XWalk (in)	N/A
N/A	Any Obstructions?	N/A	N/A	Storm Grate/Utility Hazard?	N/A
	Obstruction Type			Storm Grate/Utility Type	
N/A					N/A
			Yes	Surface Condition? (G/P)	Good
			No	Curb Slope (%)	5.8

Remove & Replace Curb Ramp With Two New Directional Ramps or Equivalent.
