Access Compliance Report
Public Rights-of-Way
(Curb Ramps)

Intersection ID: 14079	Main Street: S_KINGS_DR	Cross Street: LUTHER_ST	Location:	S
ADA ID: 2D750048379A	Ramp Type: Combination1Diag	Initial Pass/Fail: Fail	Overall Compliance: No	Severity Score: 0

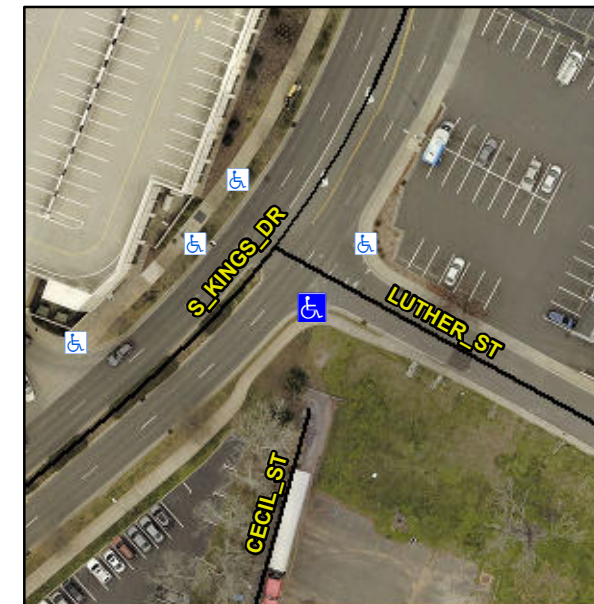
RT RP < 5%

Not Found, R304.5.3, R304.3.2

Compliance	Description	Data	Compliance	Description	Data
N/A	Ramp Length LT (in)	42.0	N/A	Ramp Length RT (in)	43.0
Yes	Ramp Width LT (in)	72.0	Yes	Ramp Width RT (in)	72.0
No	Ramp Slope LT (%)	15.8	Yes	Ramp Slope RT (%)	1.7
No	Ramp XSlope LT (%)	7.0	Yes	Ramp XSlope RT (%)	0.6
N/A	Ramp Length (in)	24.0	Yes	Ramp Slope (%)	5.5
Yes	Ramp Width (in)	48.0	No	Ramp XSlope (%)	3.5
N/A	Flare Type LT	N/A	N/A	Flare Type RT	N/A
N/A	Flare Slope LT (%)	N/A	N/A	Flare Slope RT (%)	N/A
N/A	Flare Traversable LT?	N/A	N/A	Flare Traversable RT?	N/A
N/A	Landing Length (in)	N/A	N/A	DWS Provided?	N/A
N/A	Landing Width (in)	N/A	N/A	DWS Contrast?	N/A
N/A	Landing Slope (%)	N/A	N/A	DWS Length (in)	N/A
N/A	Landing X Slope (%)	N/A	N/A	DWS Full Width?	N/A
N/A	Landing Curb? (Y/N)	N/A	N/A	DWS Offset (in)	N/A
N/A	Shared Landing?	N/A			
N/A	Gutter Ponding?	N/A	N/A	Gutter Slope (%)	N/A
N/A	Gutter Lip Ht (in)	N/A	N/A	Gutter X Slope (%)	N/A
N/A	Painted X Walk1?	Yes	N/A	Painted X Walk2?	No

Remove & Replace Curb Ramp With Two New Directional Ramps or Equivalent.
