Access Compliance Report
Public Rights-of-Way
(Curb Ramps)

Intersection ID: 4787 | **Main Street:** LOWEN_RD | **Cross Street:** SIPES_LN | **Location:** SW

ADA ID: 2DA992E97E32 | **Ramp Type:** Perp | **Initial Pass/Fail:** Fail | **Overall Compliance:** No | **Severity Score:** 22.5

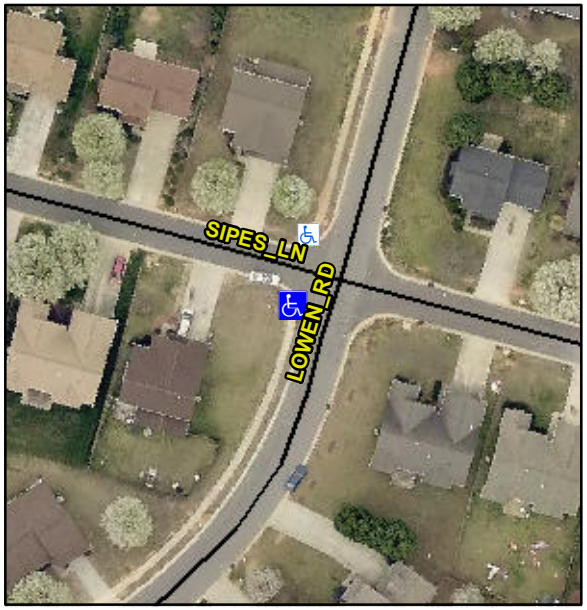
Not Found, R304.5.1, R304.2.2, R304.5.3

Remove & Replace Entire Ramp.

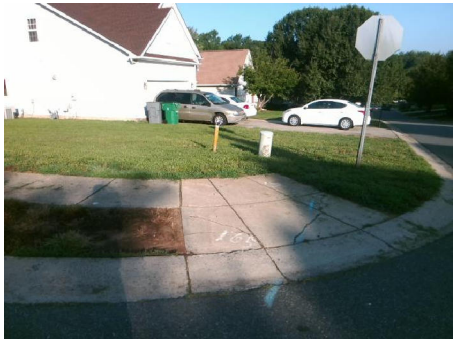
Compliance	Description	Data	Compliance	Description	Data
N/A	Ramp Length (in)	45.5	No	Ramp Slope (%)	9.0
No	Ramp Width (in)	40.0	No	Ramp XSlope (%)	4.2
N/A	Flare Type LT	N/A	N/A	Flare Type RT	N/A
N/A	Flare Slope LT (%)	N/A	N/A	Flare Slope RT (%)	N/A
N/A	Flare Traversable LT?	N/A	N/A	Flare Traversable RT?	N/A
N/A	Landing Length (in)	N/A	N/A	DWS Provided?	N/A
N/A	Landing Width (in)	N/A	N/A	DWS Contrast?	N/A
N/A	Landing Slope (%)	N/A	N/A	DWS Length (in)	N/A
N/A	Landing X Slope (%)	N/A	N/A	DWS Full Width?	N/A
N/A	Landing Curb? (Y/N)	N/A	N/A	DWS Offset (in)	N/A
N/A	Shared Landing?	N/A			
N/A	Gutter Ponding?	N/A	N/A	Gutter Slope (%)	N/A
N/A	Gutter Lip Ht (in)	N/A	N/A	Gutter X Slope (%)	N/A
N/A	Painted X Walk1?	No	N/A	Painted X Walk2?	N/A
	X Walk 1 Direction	To N		X Walk 2 Direction	N/A
N/A	X Walk 1 Width (in)	N/A	N/A	X Walk 2 Width (in)	N/A
	X Walk 1 Slope (%)	2.1		X Walk 2 Slope (%)	N/A

X Walk 1 X Slope (%)	5.5		X Walk 2 X Slope (%)	N/A
N/A	Ramp inside XWalk1?	N/A	N/A	Ramp inside XWalk2?	N/A
	Road Slope (%)	N/A	N/A	Clear Space?	N/A
	Road X Slope (%)	N/A	N/A	Clear Space to XWalk (in)	N/A
N/A	Any Obstructions?	N/A	N/A	Storm Grate/Utility Hazard?	N/A
	Obstruction Type			Storm Grate/Utility Type	
		N/A			N/A
			Yes	Surface Condition? (G/P)	Good
