Access Compliance Report

## Public Rights-of-Way
(Curb Ramps)

Intersection ID: 44943	Main Street: COLTART_CT	Cross Street: LARIMER_LN	Location: N
ADA ID: 2E16A97E6670	Ramp Type: PerpDiag	Initial Pass/Fail: Fail	Overall Compliance: No	Severity Score: 8.75

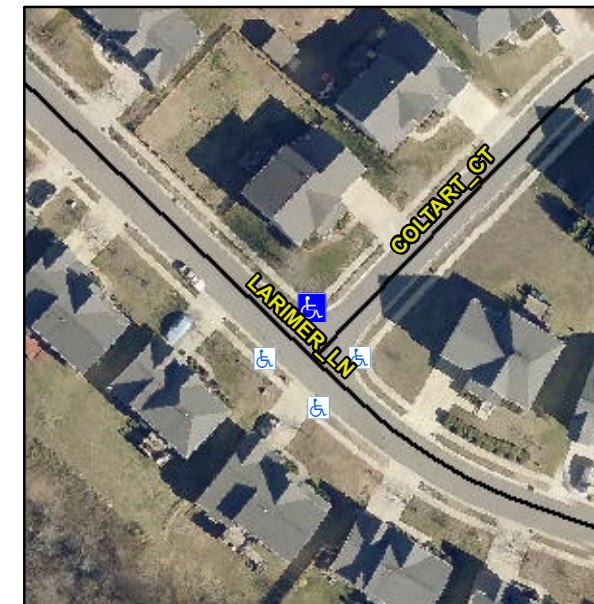
Not Found, R304.5.1

Compliance	Description	Data	Compliance	Description	Data
N/A	Ramp Length (in)	48.0	Yes	Ramp Slope (%)	5.0
No	Ramp Width (in)	46.0	Yes	Ramp XSlope (%)	0.0
N/A	Flare Type LT	N/A	N/A	Flare Type RT	N/A
N/A	Flare Slope LT (%)	N/A	N/A	Flare Slope RT (%)	N/A
N/A	Flare Traversable LT?	N/A	N/A	Flare Traversable RT?	N/A
N/A	Landing Length (in)	N/A	N/A	DWS Provided?	N/A
N/A	Landing Width (in)	N/A	N/A	DWS Contrast?	N/A
N/A	Landing Slope (%)	N/A	N/A	DWS Length (in)	N/A
N/A	Landing X Slope (%)	N/A	N/A	DWS Full Width?	N/A
N/A	Landing Curb? (Y/N)	N/A	N/A	DWS Offset (in)	N/A
N/A	Shared Landing?	N/A			
N/A	Gutter Ponding?	N/A	N/A	Gutter Slope (%)	N/A
N/A	Gutter Lip Ht (in)	N/A	N/A	Gutter X Slope (%)	N/A
N/A	Painted X Walk1?	No	N/A	Painted X Walk2?	No
	X Walk 1 Direction	To SW		X Walk 2 Direction	To SE
N/A	X Walk 1 Width (in)	N/A	N/A	X Walk 2 Width (in)	N/A
	X Walk 1 Slope (%)	1.3		X Walk 2 Slope (%)	0.8
	X Walk 1 X Slope (%)	1.8		X Walk 2 X Slope (%)	1.3

Remove & Replace Curb Ramp With Two New Directional Ramps or Equivalent.

Total Cost: $ 3200.00
