Access Compliance Report
Public Rights-of-Way
(Curb Ramps)

Intersection ID: 31749	Main Street: WASHOE_PINE_LN	Cross Street: MONARCH_BIRCH_LN	Location: W
ADA ID: 2E87186D1578	Ramp Type: PerpDiag	Initial Pass/Fail: Fail	Overall Compliance: No	Severity Score: 12.5

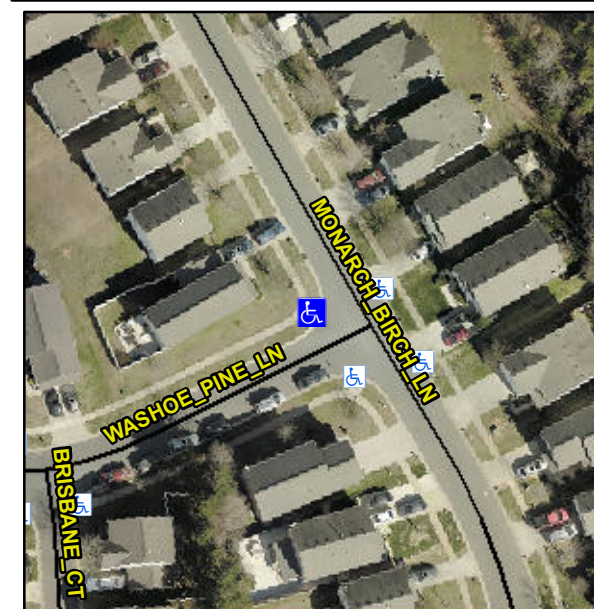
Not Found, R304.2.2

Compliance	Description	Data	Compliance	Description	Data
N/A	Ramp Length (in)	83.0	No	Ramp Slope (%)	8.8
Yes	Ramp Width (in)	48.0	Yes	Ramp XSlope (%)	1.4
N/A	Flare Type LT	N/A	N/A	Flare Type RT	N/A
N/A	Flare Slope LT (%)	N/A	N/A	Flare Slope RT (%)	N/A
N/A	Flare Traversable LT?	N/A	N/A	Flare Traversable RT?	N/A
N/A	Landing Length (in)	N/A	N/A	DWS Provided?	N/A
N/A	Landing Width (in)	N/A	N/A	DWS Contrast?	N/A
N/A	Landing Slope (%)	N/A	N/A	DWS Length (in)	N/A
N/A	Landing X Slope (%)	N/A	N/A	DWS Full Width?	N/A
N/A	Landing Curb? (Y/N)	N/A	N/A	DWS Offset (in)	N/A
N/A	Shared Landing?	N/A			
N/A	Gutter Ponding?	N/A	N/A	Gutter Slope (%)	N/A
N/A	Gutter Lip Ht (in)	N/A	N/A	Gutter X Slope (%)	N/A
N/A	Painted X Walk1?	No	N/A	Painted X Walk2?	No
	X Walk 1 Direction	To SE		X Walk 2 Direction	To NE
N/A	X Walk 1 Width (in)	N/A	N/A	X Walk 2 Width (in)	N/A
	X Walk 1 Slope (%)	0.2		X Walk 2 Slope (%)	2.8
	X Walk 1 X Slope (%)	2.8		X Walk 2 X Slope (%)	0.8

Remove & Replace Curb Ramp With Two New Directional Ramps or Equivalent.
