Access Compliance Report
Public Rights-of-Way
(Curb Ramps)

Intersection ID: 10020951	Main Street: BENDERLOCH_DR	Cross Street: N/A		Location:	NE
ADA ID: 2EC5B352F6BF	Ramp Type: Perp	Initial Pass/Fail: Fail	Overall Compliance: No	Severity Score:	10

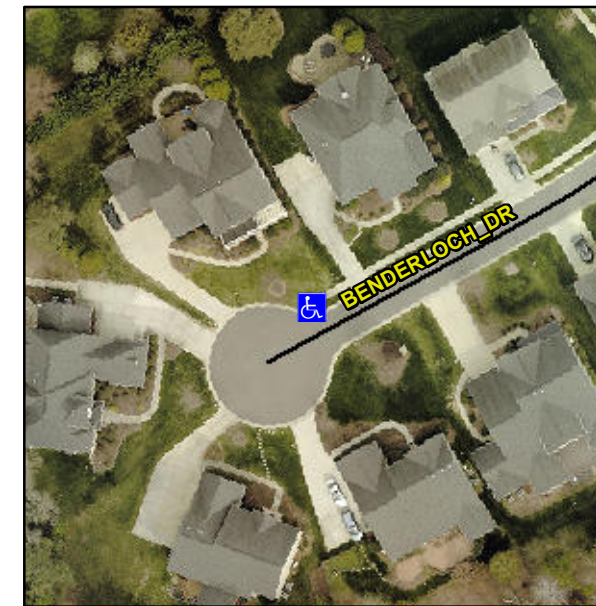
Not Found, R304.5.1, R304.5.3

Compliance	Description	Data	Compliance	Description	Data
N/A	Ramp Length (in)	49.0	Yes	Ramp Slope (%)	6.0
No	Ramp Width (in)	45.0	No	Ramp XSlope (%)	2.7
N/A	Flare Type LT	N/A	N/A	Flare Type RT	N/A
N/A	Flare Slope LT (%)	N/A	N/A	Flare Slope RT (%)	N/A
N/A	Flare Traversable LT?	N/A	N/A	Flare Traversable RT?	N/A
N/A	Landing Length (in)	N/A	N/A	DWS Provided?	N/A
N/A	Landing Width (in)	N/A	N/A	DWS Contrast?	N/A
N/A	Landing Slope (%)	N/A	N/A	DWS Length (in)	N/A
N/A	Landing X Slope (%)	N/A	N/A	DWS Full Width?	N/A
N/A	Landing Curb? (Y/N)	N/A	N/A	DWS Offset (in)	N/A
N/A	Shared Landing?	N/A			
N/A	Gutter Ponding?	N/A	N/A	Gutter Slope (%)	N/A
N/A	Gutter Lip Ht (in)	N/A	N/A	Gutter X Slope (%)	N/A
N/A	Painted X Walk1?	No	N/A	Painted X Walk2?	N/A
	X Walk 1 Direction	To S		X Walk 2 Direction	N/A
N/A	X Walk 1 Width (in)	N/A	N/A	X Walk 2 Width (in)	N/A
	X Walk 1 Slope (%)	5.2		X Walk 2 Slope (%)	N/A
	X Walk 1 X Slope (%)	1.7		X Walk 2 X Slope (%)	N/A

Remove & Replace Entire Ramp.
