Access Compliance Report
Public Rights-of-Way
(Curb Ramps)

Intersection ID: 52442	Main Street: WOODWARD_AV	Cross Street: BENDING_BIRCH_PL	Location:	SW
ADA ID: 2EE14052E679	Ramp Type: Directional1	Initial Pass/Fail: Fail	Overall Compliance: No	Severity Score: 13.75

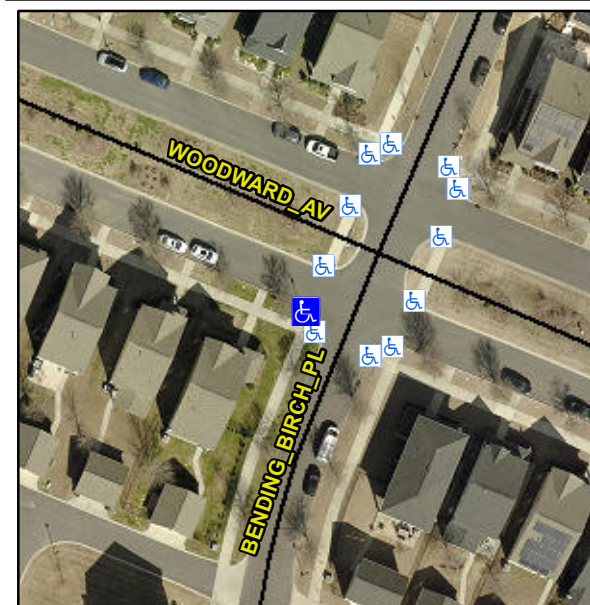
Compliance	Description	Data	Compliance	Description	Data
N/A	Ramp Length (in)	79.0	N/A	Grade Break?	N/A
Yes	Ramp Width (in)	60.0	N/A	Grade Break Slope (%)	0.0
No	Ramp Slope (%)	9.1	N/A	Grade Break XSlope (%)	0.0
Yes	Ramp XSlope (%)	2.8			
N/A	Flare Type LT	N/A	N/A	Flare Type RT	N/A
N/A	Flare Slope LT (%)	N/A	N/A	Flare Slope RT (%)	0.0
N/A	Flare Traversable LT?	N/A	N/A	Flare Traversable RT?	N/A
N/A	Landing Length (in)	0.0	N/A	DWS Provided?	N/A
N/A	Landing Width (in)	0.0	N/A	DWS Contrast?	N/A
N/A	Landing Slope (%)	0.0	N/A	DWS Length (in)	N/A
N/A	Landing X Slope (%)	0.0	N/A	DWS Full Width?	N/A
N/A	Landing Curb? (Y/N)	N/A	N/A	DWS Offset LT (in)	N/A
N/A	Shared Landing?	N/A	N/A	DWS Offset RT (in)	N/A
N/A	Gutter Ponding?	0.0	N/A	Gutter Slope (%)	N/A
N/A	Gutter Lip Ht (in)	2.0	N/A	Gutter X Slope (%)	N/A
N/A	Painted X Walk1?	No		Road Slope (%)	2.9
	X Walk 1 Direction	To N		Road X Slope (%)	6.1
	X Walk 1 Width (in)	N/A		Clear Space?	N/A

Remove & Replace Entire Ramp.
