Access Compliance Report
Public Rights-of-Way
(Curb Ramps)

Intersection ID: 12704	Main Street: E_5TH_ST	Cross Street: N_DAVIDSON_ST	Location: E
ADA ID: 2F346303809D	Ramp Type: PerpDiag	Initial Pass/Fail: Fail	Overall Compliance: No	Severity Score: 25

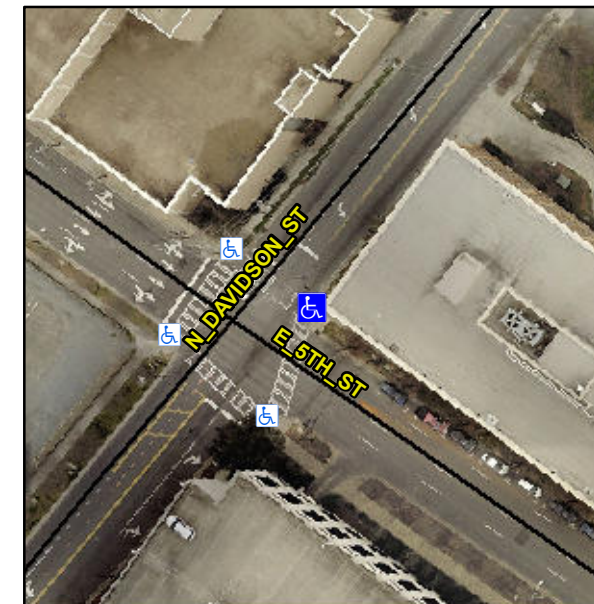
Not Found, R304.2.2

Compliance	Description	Data	Compliance	Description	Data
N/A	Ramp Length (in)	78.0	No	Ramp Slope (%)	12.2
Yes	Ramp Width (in)	60.0	Yes	Ramp XSlope (%)	0.9
N/A	Flare Type LT	N/A	N/A	Flare Type RT	N/A
N/A	Flare Slope LT (%)	N/A	N/A	Flare Slope RT (%)	N/A
N/A	Flare Traversable LT?	N/A	N/A	Flare Traversable RT?	N/A
N/A	Landing Length (in)	N/A	N/A	DWS Provided?	N/A
N/A	Landing Width (in)	N/A	N/A	DWS Contrast?	N/A
N/A	Landing Slope (%)	N/A	N/A	DWS Length (in)	N/A
N/A	Landing X Slope (%)	N/A	N/A	DWS Full Width?	N/A
N/A	Landing Curb? (Y/N)	N/A	N/A	DWS Offset (in)	N/A
N/A	Shared Landing?	N/A			
N/A	Gutter Ponding?	N/A	N/A	Gutter Slope (%)	N/A
N/A	Gutter Lip Ht (in)	N/A	N/A	Gutter X Slope (%)	N/A
N/A	Painted X Walk1?	Yes	N/A	Painted X Walk2?	Yes
	X Walk 1 Direction	To NW		X Walk 2 Direction	To SW
N/A	X Walk 1 Width (in)	103.0	N/A	X Walk 2 Width (in)	89.0
	X Walk 1 Slope (%)	1.3		X Walk 2 Slope (%)	5.0
	X Walk 1 X Slope (%)	3.6		X Walk 2 X Slope (%)	2.6

Remove & Replace Curb Ramp With Two New Directional Ramps or Equivalent.
