Access Compliance Report
Public Rights-of-Way
(Curb Ramps)

Intersection ID: 28103	**Main Street:** COMMUNITY_HOUSE_RD	**Cross Street:** PROVIDENCE_RD	**Location:** NW
ADA ID: 313432984106	**Ramp Type:** Para	**Initial Pass/Fail:** Fail **Overall Compliance:** No	**Severity Score:** 12.5

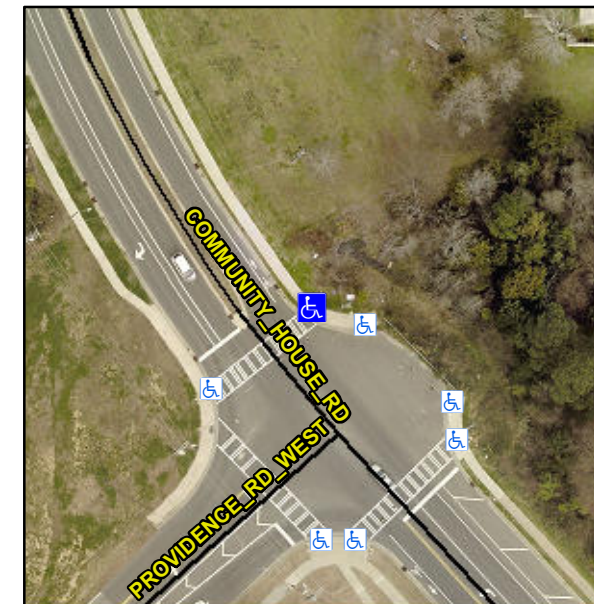
R304.3.2

Compliance	Description	Data	Compliance	Description	Data
N/A	Ramp Length LT (in)	57.0	N/A	Ramp Length RT (in)	57.0
Yes	Ramp Width LT (in)	62.0	Yes	Ramp Width RT (in)	59.0
No	Ramp Slope LT (%)	9.3	Yes	Ramp Slope RT (%)	5.6
Yes	Ramp XSlope LT (%)	0.9	Yes	Ramp XSlope RT (%)	0.9
N/A	Landing Length (in)	N/A	N/A	DWS Provided?	N/A
N/A	Landing Width (in)	N/A	N/A	DWS Contrast?	N/A
N/A	Landing Slope (%)	N/A	N/A	DWS Length (in)	N/A
N/A	Landing X Slope (%)	N/A	N/A	DWS Full Width?	N/A
N/A	Landing Curb? (Y/N)	N/A	N/A	DWS Offset (in)	N/A
N/A	Shared Landing?	N/A			
N/A	Gutter Ponding?	N/A	N/A	Gutter Slope (%)	N/A
N/A	Gutter Lip Ht (in)	N/A	N/A	Gutter X Slope (%)	N/A
N/A	Painted X Walk1?	Yes	N/A	Painted X Walk2?	N/A
	X Walk 1 Direction	To SW		X Walk 2 Direction	N/A
N/A	X Walk 1 Width (in)	129.0	N/A	X Walk 2 Width (in)	N/A
	X Walk 1 Slope (%)	3.8		X Walk 2 Slope (%)	N/A
	X Walk 1 X Slope (%)	0.2		X Walk 2 X Slope (%)	N/A
N/A	Ramp inside XWalk1?	Yes	N/A	Ramp inside XWalk2?	N/A

Remove & Replace Entire Ramp.
