Access Compliance Report
Public Rights-of-Way
(Curb Ramps)

Intersection ID: 2726	**Main Street:** CARDINAL_POINT_RD	**Cross Street:** GOLDENBLUSH_CR	**Location:**	**N**
ADA ID: 31CBBEDEDE29	**Ramp Type:** Perp	**Initial Pass/Fail:** Pass	**Overall Compliance:** No	**Severity Score:** 5

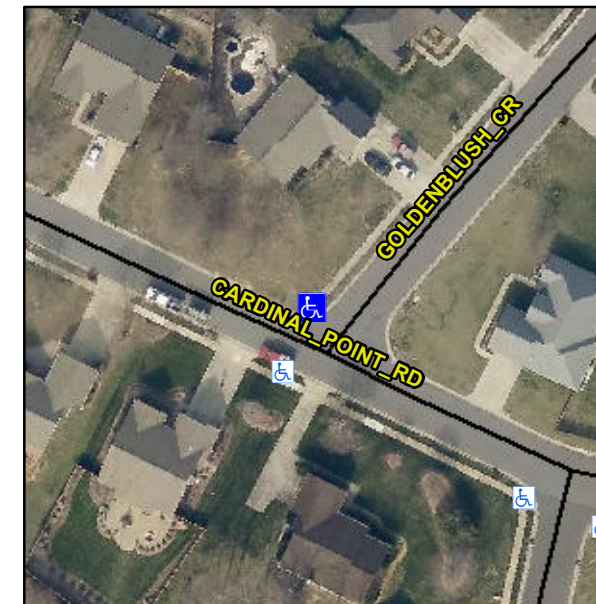
Not Found, R304.2.1, R304.2.2-Perp, R304.3.2-Para, R305.2, R304.5.4

Compliance	Description	Data	Compliance	Description	Data
N/A	Ramp Length (in)	49.0	Yes	Ramp Slope (%)	5.8
Yes	Ramp Width (in)	48.0	Yes	Ramp XSlope (%)	1.0
N/A	Flare Type LT	Sloped	N/A	Flare Type RT	N/A
N/A	Flare Slope LT (%)	8.9	N/A	Flare Slope RT (%)	3.6
N/A	Flare Traversable LT?	No	N/A	Flare Traversable RT?	No
No	Landing Length (in)	46.0	Yes	DWS Provided?	Yes
Yes	Landing Width (in)	48.0	Yes	DWS Contrast?	Yes
No	Landing Slope (%)	3.6	Yes	DWS Length (in)	25.5
Yes	Landing X Slope (%)	2.0	Yes	DWS Full Width?	Yes
N/A	Landing Curb? (Y/N)	No	No	DWS Offset (in)	3.0
N/A	Shared Landing?	No			
Yes	Gutter Ponding?	No	No	Gutter Slope (%)	9.3
Yes	Gutter Lip Ht (in)	0.0	Yes	Gutter X Slope (%)	3.4
N/A	Painted X Walk1?	No	N/A	Painted X Walk2?	N/A
	X Walk 1 Direction	To SW		X Walk 2 Direction	N/A
N/A	X Walk 1 Width (in)	N/A	N/A	X Walk 2 Width (in)	N/A
	X Walk 1 Slope (%)	0.6		X Walk 2 Slope (%)	N/A
	X Walk 1 X Slope (%)	4.2		X Walk 2 X Slope (%)	N/A

N/A	Ramp inside XWalk1?	N/A	N/A	Ramp inside XWalk2?	N/A
	Road Slope (%)	N/A	N/A	Clear Space?	Yes
	Road X Slope (%)	N/A	N/A	Clear Space to XWalk (in)	N/A
Yes	Any Obstructions?	No	Yes	Storm Grate/Utility Hazard?	No
	Obstruction Type			Storm Grate/Utility Type	
	N/A				N/A
			Yes	Surface Condition? (G/P)	Good

Remove & Replace Entire Ramp.
Remove & Replace Gutter.
