Access Compliance Report
Public Rights-of-Way
(Curb Ramps)

Intersection ID: N/A	Main Street: 6TH_ST	Cross Street: N/A	Location: W
ADA ID: 322FDBEDD13B	Ramp Type: Directional1	Initial Pass/Fail: Pass — Overall Compliance: No	Severity Score: 0

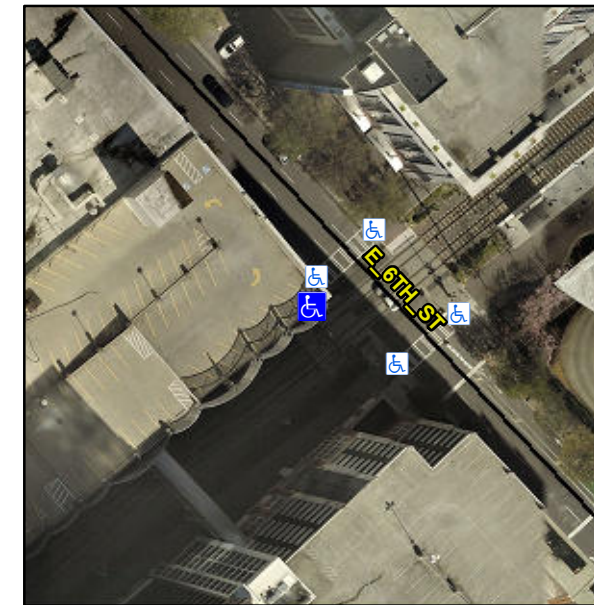
GB RUN SLOPE 22%

Compliance	Description	Data	Compliance	Description	Data
N/A	Ramp Length (in)	70.0	Yes	Grade Break?	Yes
Yes	Ramp Width (in)	118.0	No	Grade Break Slope (%)	22.0
Yes	Ramp Slope (%)	3.2	Yes	Grade Break XSlope (%)	1.3
Yes	Ramp XSlope (%)	1.3			
N/A	Flare Type LT	N/A	N/A	Flare Type RT	N/A
N/A	Flare Slope LT (%)	N/A	N/A	Flare Slope RT (%)	N/A
N/A	Flare Traversable LT?	N/A	N/A	Flare Traversable RT?	N/A
Yes	Landing Length (in)	61.0	Yes	DWS Provided?	Yes
Yes	Landing Width (in)	118.0	Yes	DWS Contrast?	Yes
Yes	Landing Slope (%)	0.8	Yes	DWS Length (in)	32.0
Yes	Landing X Slope (%)	0.1	Yes	DWS Full Width?	Yes
N/A	Landing Curb? (Y/N)	N/A	No	DWS Offset LT (in)	23.5
N/A	Shared Landing?	No	Yes	DWS Offset RT (in)	33.0
Yes	Gutter Ponding?	No	Yes	Gutter Slope (%)	0.1
Yes	Gutter Lip Ht (in)	0.0	Yes	Gutter X Slope (%)	0.3
N/A	Painted X Walk1?	No		Road Slope (%)	1.2
	X Walk 1 Direction	To SE		Road X Slope (%)	0.1
	X Walk 1 Width (in)	N/A		Clear Space?	Yes

X Walk 1 Slope (%)	1.2	N/A	Clear Space to XWalk (in)	N/A
	X Walk 1 X Slope (%)	0.1	No	Storm Grate/Utility Hazard?	Yes
N/A	Ramp inside XWalk1?	N/A		Storm Grate/Utility Type	
Yes	Any Obstructions?	No		**CDOT ELECTRIC VAULT**	
	Obstruction Type		Yes	Surface Condition? (G/P)	Good
N/A			Yes	Curb Slope (%)	0.1

**Remove & Replace Entire Ramp.
Utility Present.**
