Access Compliance Report
Public Rights-of-Way
(Curb Ramps)

Intersection ID: 50464	**Main Street: LENOX_POINTE_DR**	**Cross Street: SANDY_PORTER_RD**	**Location:** SE
ADA ID: 33F36FE9E8A4	**Ramp Type: Perp**	**Initial Pass/Fail: Pass** **Overall Compliance: No**	**Severity Score:** 0

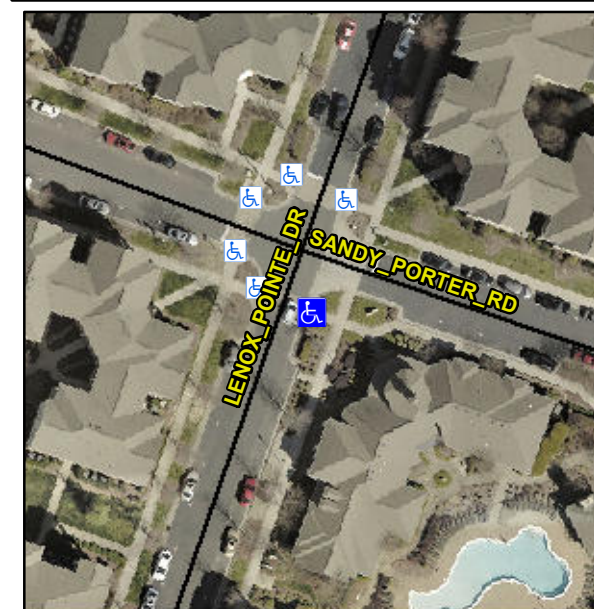
Compliance	Description	Data	Compliance	Description	Data
N/A	Ramp Length (in)	167.0	Yes	Ramp Slope (%)	6.4
Yes	Ramp Width (in)	48.0	Yes	Ramp XSlope (%)	1.2
N/A	Flare Type LT	Sloped	N/A	Flare Type RT	N/A
N/A	Flare Slope LT (%)	5.8	N/A	Flare Slope RT (%)	7.8
N/A	Flare Traversable LT?	No	N/A	Flare Traversable RT?	No
Yes	Landing Length (in)	70.0	Yes	DWS Provided?	Yes
Yes	Landing Width (in)	62.0	Yes	DWS Contrast?	Yes
No	Landing Slope (%)	4.2	Yes	DWS Length (in)	24.0
Yes	Landing X Slope (%)	1.6	Yes	DWS Full Width?	Yes
N/A	Landing Curb? (Y/N)	No	No	DWS Offset (in)	5.5
N/A	Shared Landing?	No			
Yes	Gutter Ponding?	No	Yes	Gutter Slope (%)	2.3
Yes	Gutter Lip Ht (in)	0.0	Yes	Gutter X Slope (%)	1.7
N/A	Painted X Walk1?	Yes	N/A	Painted X Walk2?	N/A
	X Walk 1 Direction	To W		X Walk 2 Direction	N/A
N/A	X Walk 1 Width (in)	144.0	N/A	X Walk 2 Width (in)	N/A
	X Walk 1 Slope (%)	0.7		X Walk 2 Slope (%)	N/A
	X Walk 1 X Slope (%)	1.6		X Walk 2 X Slope (%)	N/A

Yes	Ramp inside XWalk1?	Yes	N/A	Ramp inside XWalk2?	N/A
	Road Slope (%)	N/A	N/A	Clear Space?	Yes
	Road X Slope (%)	N/A	N/A	Clear Space to XWalk (in)	N/A
Yes	Any Obstructions?	No	Yes	Storm Grate/Utility Hazard?	No
	Obstruction Type			Storm Grate/Utility Type	
		N/A			N/A
			Yes	Surface Condition? (G/P)	Good

Remove & Replace Entire Ramp.
