Access Compliance Report
Public Rights-of-Way
(Curb Ramps)

Intersection ID: 7635	**Main Street: PHEASANT_GLEN_RD**	**Cross Street: QUAIL_ST**	**Location: NW**
ADA ID: 35B4B99889E0	**Ramp Type: PerpDiag**	**Initial Pass/Fail: Fail**	**Overall Compliance: No** / **Severity Score: 33.75**

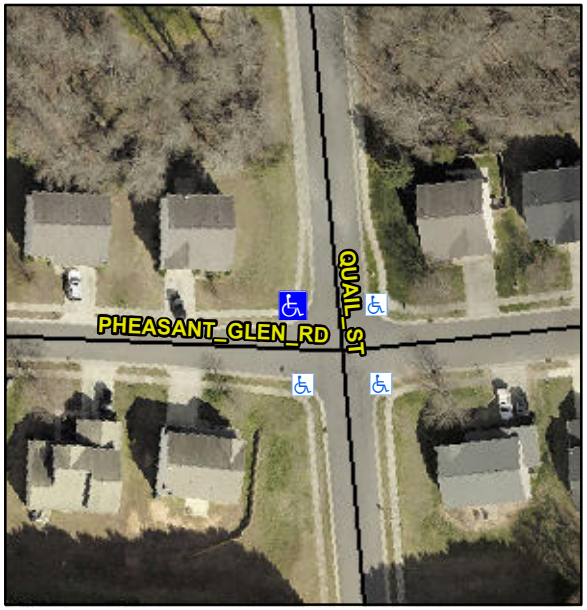
Not Found, R304.5.1, R304.5.3

Compliance	Description	Data	Compliance	Description	Data
N/A	Ramp Length (in)	48.0	Yes	Ramp Slope (%)	7.3
No	Ramp Width (in)	46.0	No	Ramp XSlope (%)	9.6
N/A	Flare Type LT	N/A	N/A	Flare Type RT	N/A
N/A	Flare Slope LT (%)	N/A	N/A	Flare Slope RT (%)	N/A
N/A	Flare Traversable LT?	N/A	N/A	Flare Traversable RT?	N/A
N/A	Landing Length (in)	N/A	N/A	DWS Provided?	N/A
N/A	Landing Width (in)	N/A	N/A	DWS Contrast?	N/A
N/A	Landing Slope (%)	N/A	N/A	DWS Length (in)	N/A
N/A	Landing X Slope (%)	N/A	N/A	DWS Full Width?	N/A
N/A	Landing Curb? (Y/N)	N/A	N/A	DWS Offset (in)	N/A
N/A	Shared Landing?	N/A			
N/A	Gutter Ponding?	N/A	N/A	Gutter Slope (%)	N/A
N/A	Gutter Lip Ht (in)	N/A	N/A	Gutter X Slope (%)	N/A
N/A	Painted X Walk1?	No	N/A	Painted X Walk2?	No
	X Walk 1 Direction	To S		X Walk 2 Direction	To E
N/A	X Walk 1 Width (in)	N/A	N/A	X Walk 2 Width (in)	N/A
	X Walk 1 Slope (%)	6.7		X Walk 2 Slope (%)	1.2
	X Walk 1 X Slope (%)	0.7		X Walk 2 X Slope (%)	9.4

Remove & Replace Curb Ramp With Two New Directional Ramps or Equivalent.
