Access Compliance Report
Public Rights-of-Way
(Curb Ramps)

Intersection ID: 53044 **Main Street:** MELODY_WOODS_CT **Cross Street:** WILLOW_OAK_RD **Location:** NE

ADA ID: 36673507F5D7 **Ramp Type:** Perp **Initial Pass/Fail:** Fail **Overall Compliance:** No **Severity Score:** 1.25

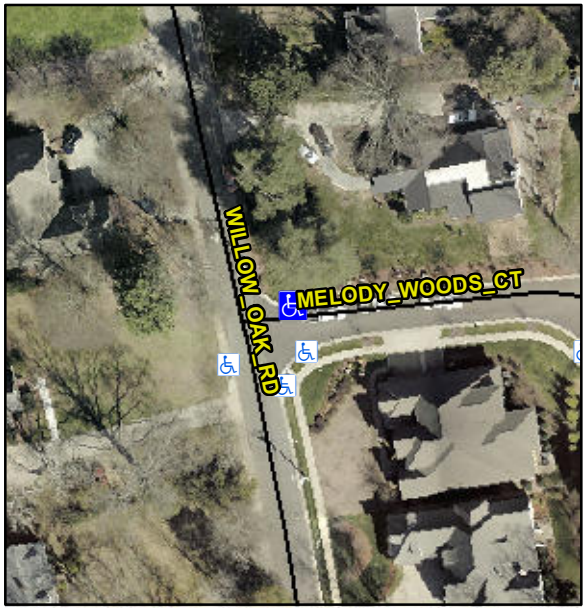
Not Found, R304.5.3

Compliance	Description	Data	Compliance	Description	Data
N/A	Ramp Length (in)	110.0	Yes	Ramp Slope (%)	5.9
Yes	Ramp Width (in)	48.0	No	Ramp XSlope (%)	3.9
N/A	Flare Type LT	N/A	N/A	Flare Type RT	N/A
N/A	Flare Slope LT (%)	N/A	N/A	Flare Slope RT (%)	N/A
N/A	Flare Traversable LT?	N/A	N/A	Flare Traversable RT?	N/A
N/A	Landing Length (in)	N/A	N/A	DWS Provided?	N/A
N/A	Landing Width (in)	N/A	N/A	DWS Contrast?	N/A
N/A	Landing Slope (%)	N/A	N/A	DWS Length (in)	N/A
N/A	Landing X Slope (%)	N/A	N/A	DWS Full Width?	N/A
N/A	Landing Curb? (Y/N)	N/A	N/A	DWS Offset (in)	N/A
N/A	Shared Landing?	N/A			
N/A	Gutter Ponding?	N/A	N/A	Gutter Slope (%)	N/A
N/A	Gutter Lip Ht (in)	2.0	N/A	Gutter X Slope (%)	N/A
N/A	Painted X Walk1?	No	N/A	Painted X Walk2?	N/A
	X Walk 1 Direction	To S		X Walk 2 Direction	N/A
N/A	X Walk 1 Width (in)	N/A	N/A	X Walk 2 Width (in)	N/A
	X Walk 1 Slope (%)	0.3		X Walk 2 Slope (%)	N/A
	X Walk 1 X Slope (%)	3.3		X Walk 2 X Slope (%)	N/A

Remove & Replace Entire Ramp.
