# Access Compliance Report
Public Rights-of-Way
(Curb Ramps)

Intersection ID: 42492	Main Street: ALMA_BLOUNT_BV	Cross Street: JAMES_BLAKENEY_AV	Location:	NE
ADA ID: 37D90951ECD4	Ramp Type: PerpDiag	Initial Pass/Fail: Fail	Overall Compliance: No	Severity Score: 30

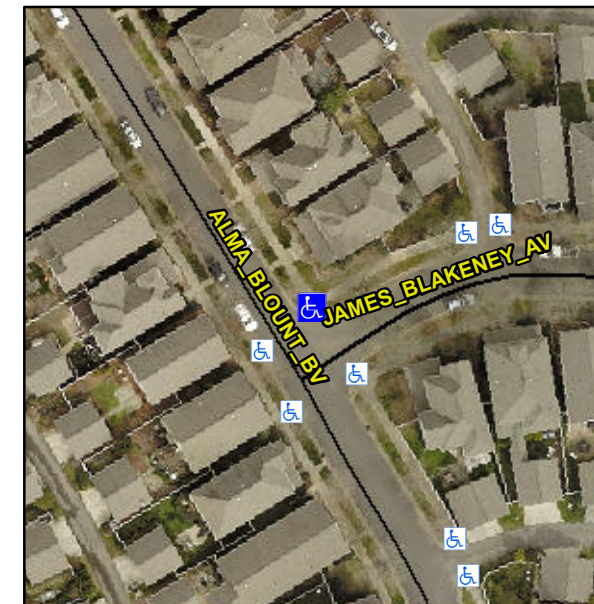
R304.5.1, R304.2.2

Compliance	Description	Data	Compliance	Description	Data
N/A	Ramp Length (in)	77.0	No	Ramp Slope (%)	9.9
No	Ramp Width (in)	32.0	Yes	Ramp XSlope (%)	0.6
N/A	Flare Type LT	N/A	N/A	Flare Type RT	N/A
N/A	Flare Slope LT (%)	N/A	N/A	Flare Slope RT (%)	N/A
N/A	Flare Traversable LT?	N/A	N/A	Flare Traversable RT?	N/A
N/A	Landing Length (in)	N/A	N/A	DWS Provided?	N/A
N/A	Landing Width (in)	N/A	N/A	DWS Contrast?	N/A
N/A	Landing Slope (%)	N/A	N/A	DWS Length (in)	N/A
N/A	Landing X Slope (%)	N/A	N/A	DWS Full Width?	N/A
N/A	Landing Curb? (Y/N)	N/A	N/A	DWS Offset (in)	N/A
N/A	Shared Landing?	N/A			
N/A	Gutter Ponding?	N/A	N/A	Gutter Slope (%)	N/A
N/A	Gutter Lip Ht (in)	N/A	N/A	Gutter X Slope (%)	N/A
N/A	Painted X Walk1?	No	N/A	Painted X Walk2?	No
	X Walk 1 Direction	To SW		X Walk 2 Direction	To SE
N/A	X Walk 1 Width (in)	N/A	N/A	X Walk 2 Width (in)	N/A
	X Walk 1 Slope (%)	0.5		X Walk 2 Slope (%)	0.0
	X Walk 1 X Slope (%)	0.1		X Walk 2 X Slope (%)	1.0

Remove & Replace Curb Ramp With Two New Directional Ramps or Equivalent.
