Access Compliance Report
Public Rights-of-Way
(Curb Ramps)

Intersection ID: 2419 **Main Street:** LAUREL_RUN_DR **Cross Street:** WILDBROOK_DR **Location:** N

ADA ID: 380F210308D5 **Ramp Type:** PerpDiag **Initial Pass/Fail:** Fail **Overall Compliance:** No **Severity Score:** 33.75

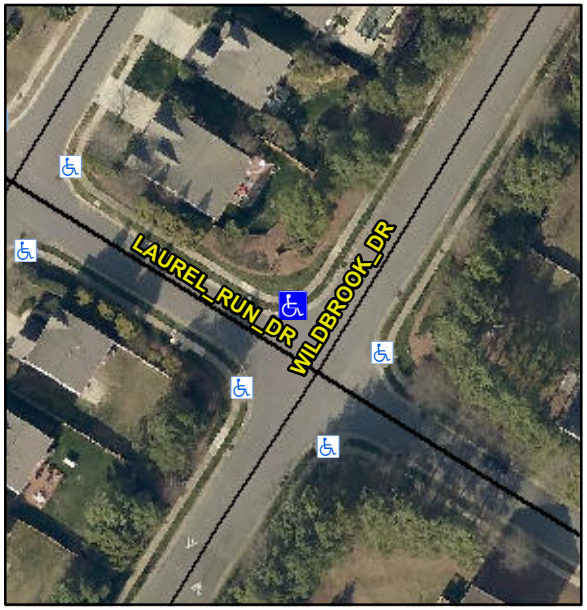
Compliance	Description	Data	Compliance	Description	Data
N/A	Ramp Length (in)	100.0	Yes	Ramp Slope (%)	6.2
No	Ramp Width (in)	39.0	No	Ramp XSlope (%)	8.4
N/A	Flare Type LT	N/A	N/A	Flare Type RT	N/A
N/A	Flare Slope LT (%)	N/A	N/A	Flare Slope RT (%)	N/A
N/A	Flare Traversable LT?	N/A	N/A	Flare Traversable RT?	N/A
N/A	Landing Length (in)	N/A	N/A	DWS Provided?	N/A
N/A	Landing Width (in)	N/A	N/A	DWS Contrast?	N/A
N/A	Landing Slope (%)	N/A	N/A	DWS Length (in)	N/A
N/A	Landing X Slope (%)	N/A	N/A	DWS Full Width?	N/A
N/A	Landing Curb? (Y/N)	N/A	N/A	DWS Offset (in)	N/A
N/A	Shared Landing?	N/A			
N/A	Gutter Ponding?	N/A	N/A	Gutter Slope (%)	N/A
N/A	Gutter Lip Ht (in)	N/A	N/A	Gutter X Slope (%)	N/A
N/A	Painted X Walk1?	No	N/A	Painted X Walk2?	No
	X Walk 1 Direction	To SW		X Walk 2 Direction	To SE
N/A	X Walk 1 Width (in)	N/A	N/A	X Walk 2 Width (in)	N/A
	X Walk 1 Slope (%)	4.3		X Walk 2 Slope (%)	1.9
	X Walk 1 X Slope (%)	8.3		X Walk 2 X Slope (%)	4.7

N/A	Ramp inside XWalk1?	N/A	N/A	Ramp inside XWalk2?	N/A
	Road Slope (%)	6.5	N/A	Clear Space?	N/A
	Road X Slope (%)	0.8	N/A	Clear Space to XWalk (in)	N/A
N/A	Any Obstructions?	N/A	N/A	Storm Grate/Utility Hazard?	N/A
	Obstruction Type			Storm Grate/Utility Type	
		N/A			N/A
			Yes	Surface Condition? (G/P)	Good

Remove & Replace Curb Ramp With Two New Directional Ramps or Equivalent.
