Access Compliance Report
Public Rights-of-Way
(Curb Ramps)

Intersection ID: 51610	Main Street: LUMSDEN_RD	Cross Street: MASTERTON_RD	Location:	E
ADA ID: 3891B64185E1	Ramp Type: PerpDiag	Initial Pass/Fail: Fail	Overall Compliance: No	Severity Score: 25

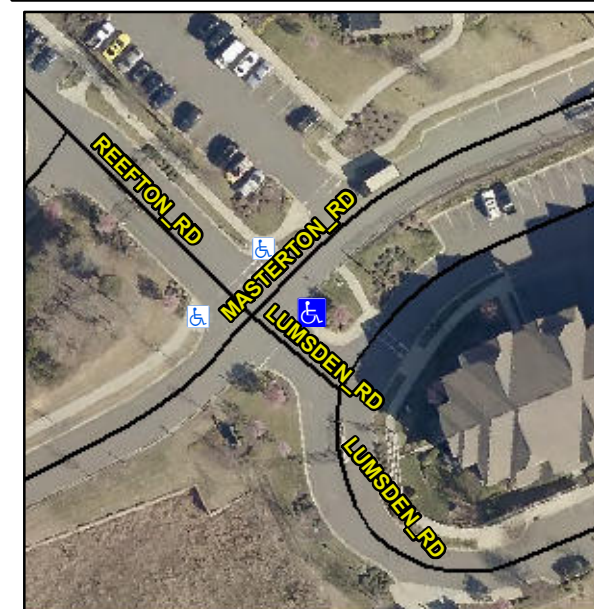
R304.5.3

Compliance	Description	Data	Compliance	Description	Data
N/A	Ramp Length (in)	61.0	Yes	Ramp Slope (%)	5.7
Yes	Ramp Width (in)	62.0	No	Ramp XSlope (%)	15.0
N/A	Flare Type LT	N/A	N/A	Flare Type RT	N/A
N/A	Flare Slope LT (%)	N/A	N/A	Flare Slope RT (%)	N/A
N/A	Flare Traversable LT?	N/A	N/A	Flare Traversable RT?	N/A
N/A	Landing Length (in)	N/A	N/A	DWS Provided?	N/A
N/A	Landing Width (in)	N/A	N/A	DWS Contrast?	N/A
N/A	Landing Slope (%)	N/A	N/A	DWS Length (in)	N/A
N/A	Landing X Slope (%)	N/A	N/A	DWS Full Width?	N/A
N/A	Landing Curb? (Y/N)	N/A	N/A	DWS Offset (in)	N/A
N/A	Shared Landing?	N/A			
N/A	Gutter Ponding?	N/A	N/A	Gutter Slope (%)	N/A
N/A	Gutter Lip Ht (in)	N/A	N/A	Gutter X Slope (%)	N/A
N/A	Painted X Walk1?	Yes	N/A	Painted X Walk2?	Yes
	X Walk 1 Direction	To NW		X Walk 2 Direction	To SW
N/A	X Walk 1 Width (in)	48.0	N/A	X Walk 2 Width (in)	36.0
	X Walk 1 Slope (%)	6.8		X Walk 2 Slope (%)	1.1
	X Walk 1 X Slope (%)	3.4		X Walk 2 X Slope (%)	4.6

N/A	Ramp inside XWalk1?	Yes	N/A	Ramp inside XWalk2?	Yes
	Road Slope (%)	4.4	N/A	Clear Space?	N/A
	Road X Slope (%)	0.3	N/A	Clear Space to XWalk (in)	N/A
N/A	Any Obstructions?	N/A	N/A	Storm Grate/Utility Hazard?	N/A
	Obstruction Type			Storm Grate/Utility Type	
	N/A				N/A
			Yes	Surface Condition? (G/P)	Good

Remove & Replace Curb Ramp With Two New Directional Ramps or Equivalent.
