Access Compliance Report
Public Rights-of-Way
(Curb Ramps)

Intersection ID: 22206 **Main Street:** MILL_POND_RD **Cross Street:** TABLE_ROCK_RD **Location:** S

ADA ID: 38B196A92D3A **Ramp Type:** PerpDiag **Initial Pass/Fail:** Pass **Overall Compliance:** No **Severity Score:** 25.25

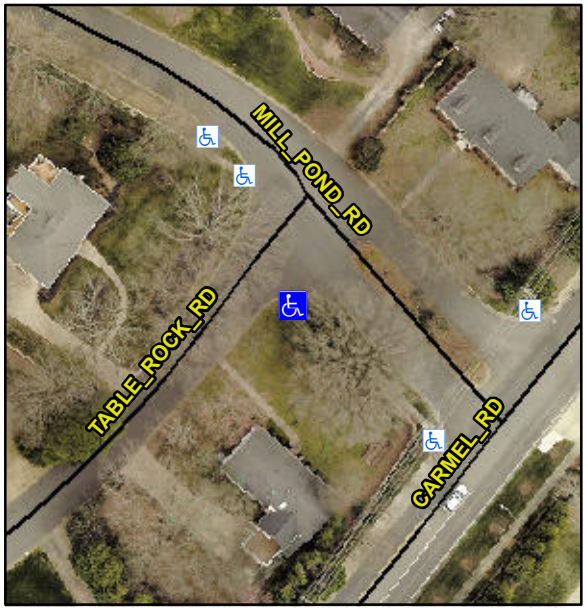
Not Found, R304.5.3, R304.2.1, R304.2.2-Perp, R304.3.2-Para, R305, R304.5.4

Compliance	Description	Data	Compliance	Description	Data
N/A	Ramp Length (in)	37.0	Yes	Ramp Slope (%)	6.1
Yes	Ramp Width (in)	48.0	No	Ramp XSlope (%)	4.1
N/A	Flare Type LT	None	N/A	Flare Type RT	N/A
N/A	Flare Slope LT (%)	N/A	N/A	Flare Slope RT (%)	N/A
N/A	Flare Traversable LT?	N/A	N/A	Flare Traversable RT?	N/A
No	Landing Length (in)	N/A	No	DWS Provided?	No
No	Landing Width (in)	N/A	N/A	DWS Contrast?	No
No	Landing Slope (%)	N/A	N/A	DWS Length (in)	N/A
No	Landing X Slope (%)	N/A	N/A	DWS Full Width?	No
N/A	Landing Curb? (Y/N)	No	N/A	DWS Offset (in)	N/A
N/A	Shared Landing?	N/A			
Yes	Gutter Ponding?	No	No	Gutter Slope (%)	7.1
Yes	Gutter Lip Ht (in)	0.0	Yes	Gutter X Slope (%)	1.4
N/A	Painted X Walk1?	No	N/A	Painted X Walk2?	No
	X Walk 1 Direction	To NE		X Walk 2 Direction	To NW
N/A	X Walk 1 Width (in)	N/A	N/A	X Walk 2 Width (in)	N/A
	X Walk 1 Slope (%)	6.6		X Walk 2 Slope (%)	4.4
	X Walk 1 X Slope (%)	1.5		X Walk 2 X Slope (%)	5.2

Remove & Replace Curb Ramp With Two New Directional Ramps or Equivalent. Remove & Replace Gutter.
