Access Compliance Report
Public Rights-of-Way
(Curb Ramps)

Intersection ID: 29951	Main Street: SMITH_CORNERS_BV	Cross Street: STATESVILLE_RD	Location:	SW
ADA ID: 38CF09888A16	Ramp Type: Perp	Initial Pass/Fail: Fail	Overall Compliance: No	Severity Score: 10

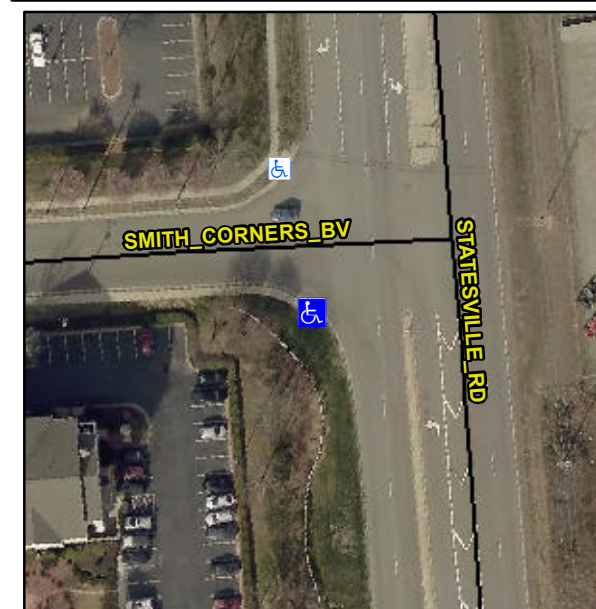
Not Found, R304.5.1, R304.5.3

Compliance	Description	Data	Compliance	Description	Data
N/A	Ramp Length (in)	49.0	Yes	Ramp Slope (%)	6.2
No	Ramp Width (in)	46.5	No	Ramp XSlope (%)	4.9
N/A	Flare Type LT	N/A	N/A	Flare Type RT	N/A
N/A	Flare Slope LT (%)	N/A	N/A	Flare Slope RT (%)	N/A
N/A	Flare Traversable LT?	N/A	N/A	Flare Traversable RT?	N/A
N/A	Landing Length (in)	N/A	N/A	DWS Provided?	N/A
N/A	Landing Width (in)	N/A	N/A	DWS Contrast?	N/A
N/A	Landing Slope (%)	N/A	N/A	DWS Length (in)	N/A
N/A	Landing X Slope (%)	N/A	N/A	DWS Full Width?	N/A
N/A	Landing Curb? (Y/N)	N/A	N/A	DWS Offset (in)	N/A
N/A	Shared Landing?	N/A			
N/A	Gutter Ponding?	N/A	N/A	Gutter Slope (%)	N/A
N/A	Gutter Lip Ht (in)	N/A	N/A	Gutter X Slope (%)	N/A
N/A	Painted X Walk1?	No	N/A	Painted X Walk2?	N/A
	X Walk 1 Direction	To N		X Walk 2 Direction	N/A
N/A	X Walk 1 Width (in)	N/A	N/A	X Walk 2 Width (in)	N/A
	X Walk 1 Slope (%)	0.5		X Walk 2 Slope (%)	N/A
	X Walk 1 X Slope (%)	5.3		X Walk 2 X Slope (%)	N/A

Remove & Replace Entire Ramp.
