Access Compliance Report
Public Rights-of-Way
(Curb Ramps)

Intersection ID: 19682	Main Street: FLODDEN_FIELD_CT	Cross Street: YORKDALE_DR	Location:	SE
ADA ID: 3A91A20B806B	Ramp Type: PerpDiag	Initial Pass/Fail: Fail	Overall Compliance: No	Severity Score: 12.5

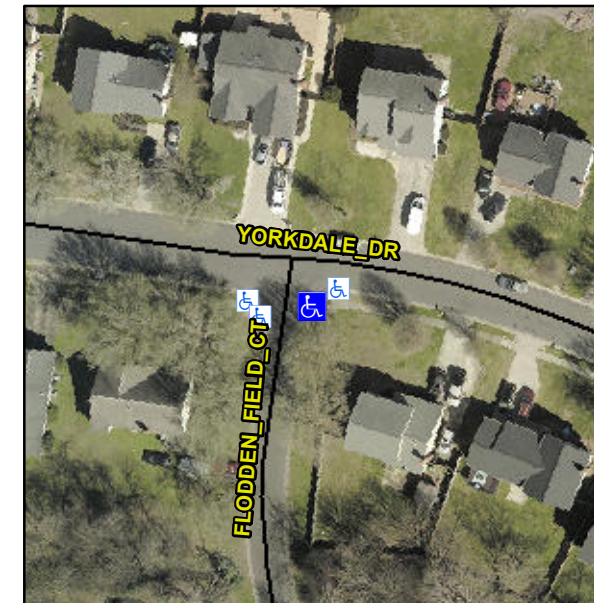
Not Found, R304.5.3

Compliance	Description	Data	Compliance	Description	Data
N/A	Ramp Length (in)	93.0	Yes	Ramp Slope (%)	7.7
Yes	Ramp Width (in)	66.0	No	Ramp XSlope (%)	5.9
N/A	Flare Type LT	N/A	N/A	Flare Type RT	N/A
N/A	Flare Slope LT (%)	N/A	N/A	Flare Slope RT (%)	N/A
N/A	Flare Traversable LT?	N/A	N/A	Flare Traversable RT?	N/A
N/A	Landing Length (in)	N/A	N/A	DWS Provided?	N/A
N/A	Landing Width (in)	N/A	N/A	DWS Contrast?	N/A
N/A	Landing Slope (%)	N/A	N/A	DWS Length (in)	N/A
N/A	Landing X Slope (%)	N/A	N/A	DWS Full Width?	N/A
N/A	Landing Curb? (Y/N)	N/A	N/A	DWS Offset (in)	N/A
N/A	Shared Landing?	N/A			
N/A	Gutter Ponding?	N/A	N/A	Gutter Slope (%)	N/A
N/A	Gutter Lip Ht (in)	N/A	N/A	Gutter X Slope (%)	N/A
N/A	Painted X Walk1?	No	N/A	Painted X Walk2?	No
	X Walk 1 Direction	To N		X Walk 2 Direction	To W
N/A	X Walk 1 Width (in)	N/A	N/A	X Walk 2 Width (in)	N/A
	X Walk 1 Slope (%)	6.8		X Walk 2 Slope (%)	2.3
	X Walk 1 X Slope (%)	2.3		X Walk 2 X Slope (%)	5.2

N/A	Ramp inside XWalk1?	N/A	N/A	Ramp inside XWalk2?	N/A
	Road Slope (%)	4.2	N/A	Clear Space?	N/A
	Road X Slope (%)	5.6	N/A	Clear Space to XWalk (in)	N/A
N/A	Any Obstructions?	N/A	N/A	Storm Grate/Utility Hazard?	N/A
	Obstruction Type			Storm Grate/Utility Type	
N/A					N/A
			Yes	Surface Condition? (G/P)	Good

Remove & Replace Curb Ramp With Two New Directional Ramps or Equivalent.
