Access Compliance Report
Public Rights-of-Way
(Curb Ramps)

Intersection ID: 28449	Main Street: LAURENFIELD_DR	Cross Street: SUMMER_CREEK_LN	Location:	S
ADA ID: 3ABDAE469CEC	Ramp Type: Perp	Initial Pass/Fail: Fail	Overall Compliance: No	Severity Score: 25

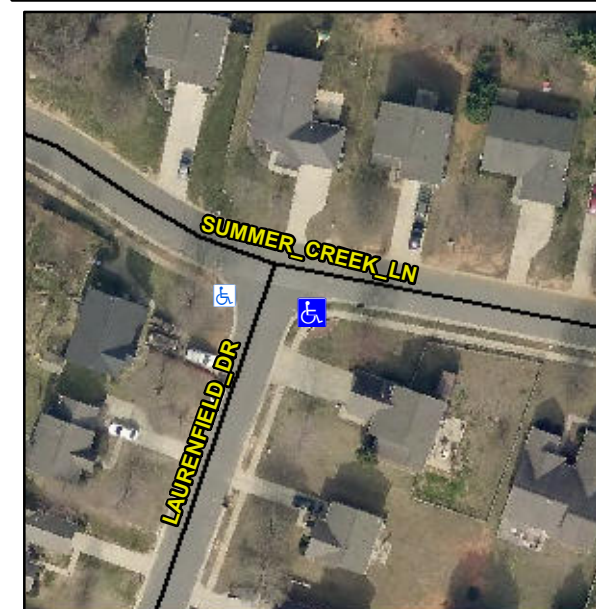
Not Found, R304.5.3

Compliance	Description	Data	Compliance	Description	Data
N/A	Ramp Length (in)	52.0	Yes	Ramp Slope (%)	5.5
Yes	Ramp Width (in)	76.0	No	Ramp XSlope (%)	13.3
N/A	Flare Type LT	N/A	N/A	Flare Type RT	N/A
N/A	Flare Slope LT (%)	N/A	N/A	Flare Slope RT (%)	N/A
N/A	Flare Traversable LT?	N/A	N/A	Flare Traversable RT?	N/A
N/A	Landing Length (in)	N/A	N/A	DWS Provided?	N/A
N/A	Landing Width (in)	N/A	N/A	DWS Contrast?	N/A
N/A	Landing Slope (%)	N/A	N/A	DWS Length (in)	N/A
N/A	Landing X Slope (%)	N/A	N/A	DWS Full Width?	N/A
N/A	Landing Curb? (Y/N)	N/A	N/A	DWS Offset (in)	N/A
N/A	Shared Landing?	N/A			
N/A	Gutter Ponding?	N/A	N/A	Gutter Slope (%)	N/A
N/A	Gutter Lip Ht (in)	N/A	N/A	Gutter X Slope (%)	N/A
N/A	Painted X Walk1?	No	N/A	Painted X Walk2?	N/A
	X Walk 1 Direction	To NW		X Walk 2 Direction	N/A
N/A	X Walk 1 Width (in)	N/A	N/A	X Walk 2 Width (in)	N/A
	X Walk 1 Slope (%)	4.7		X Walk 2 Slope (%)	N/A
	X Walk 1 X Slope (%)	8.4		X Walk 2 X Slope (%)	N/A

Remove & Replace Entire Ramp.
