Access Compliance Report
Public Rights-of-Way
(Curb Ramps)

Intersection ID: 6143	Main Street: COREOPSIS_RD	Cross Street: YARROW_RD	Location:	NW
ADA ID: 3AD86939A928	Ramp Type: Perp	Initial Pass/Fail: Fail	Overall Compliance: No	Severity Score: 46.25

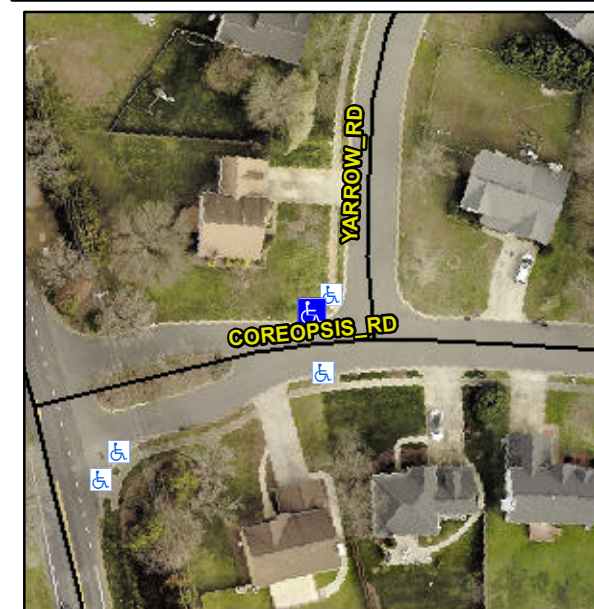
Not Found, R304.5.1, R304.2.2, R304.5.3

Compliance	Description	Data	Compliance	Description	Data
N/A	Ramp Length (in)	54.0	No	Ramp Slope (%)	11.2
No	Ramp Width (in)	47.5	No	Ramp XSlope (%)	7.0
N/A	Flare Type LT	N/A	N/A	Flare Type RT	N/A
N/A	Flare Slope LT (%)	N/A	N/A	Flare Slope RT (%)	N/A
N/A	Flare Traversable LT?	N/A	N/A	Flare Traversable RT?	N/A
N/A	Landing Length (in)	N/A	N/A	DWS Provided?	N/A
N/A	Landing Width (in)	N/A	N/A	DWS Contrast?	N/A
N/A	Landing Slope (%)	N/A	N/A	DWS Length (in)	N/A
N/A	Landing X Slope (%)	N/A	N/A	DWS Full Width?	N/A
N/A	Landing Curb? (Y/N)	N/A	N/A	DWS Offset (in)	N/A
N/A	Shared Landing?	N/A			
N/A	Gutter Ponding?	N/A	N/A	Gutter Slope (%)	N/A
N/A	Gutter Lip Ht (in)	N/A	N/A	Gutter X Slope (%)	N/A
N/A	Painted X Walk1?	No	N/A	Painted X Walk2?	N/A
	X Walk 1 Direction	To S		X Walk 2 Direction	N/A
N/A	X Walk 1 Width (in)	N/A	N/A	X Walk 2 Width (in)	N/A
	X Walk 1 Slope (%)	0.7		X Walk 2 Slope (%)	N/A
	X Walk 1 X Slope (%)	5.6		X Walk 2 X Slope (%)	N/A

Remove & Replace Entire Ramp.
