# Access Compliance Report
Public Rights-of-Way
(Curb Ramps)

Intersection ID: 49691	Main Street: OLIVIA_VIEW_CT	Cross Street: ALEXANDRA_ALLEY_DR	Location:	N
ADA ID: 3AF56945488D	Ramp Type: PerpDiag	Initial Pass/Fail: Fail	Overall Compliance: No	Severity Score: 12.5

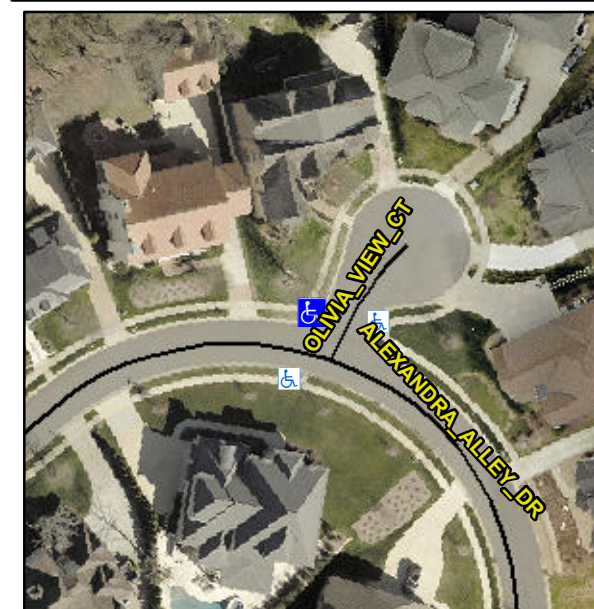
Not Found, R304.2.2

Compliance	Description	Data	Compliance	Description	Data
N/A	Ramp Length (in)	50.5	No	Ramp Slope (%)	10.2
Yes	Ramp Width (in)	48.0	Yes	Ramp XSlope (%)	1.7
N/A	Flare Type LT	N/A	N/A	Flare Type RT	N/A
N/A	Flare Slope LT (%)	N/A	N/A	Flare Slope RT (%)	N/A
N/A	Flare Traversable LT?	N/A	N/A	Flare Traversable RT?	N/A
N/A	Landing Length (in)	N/A	N/A	DWS Provided?	N/A
N/A	Landing Width (in)	N/A	N/A	DWS Contrast?	N/A
N/A	Landing Slope (%)	N/A	N/A	DWS Length (in)	N/A
N/A	Landing X Slope (%)	N/A	N/A	DWS Full Width?	N/A
N/A	Landing Curb? (Y/N)	N/A	N/A	DWS Offset (in)	N/A
N/A	Shared Landing?	N/A			
N/A	Gutter Ponding?	N/A	N/A	Gutter Slope (%)	N/A
N/A	Gutter Lip Ht (in)	N/A	N/A	Gutter X Slope (%)	N/A
N/A	Painted X Walk1?	No	N/A	Painted X Walk2?	No
	X Walk 1 Direction	To SW		X Walk 2 Direction	To SE
N/A	X Walk 1 Width (in)	N/A	N/A	X Walk 2 Width (in)	N/A
	X Walk 1 Slope (%)	0.2		X Walk 2 Slope (%)	0.5
	X Walk 1 X Slope (%)	1.4		X Walk 2 X Slope (%)	1.3

N/A	Ramp inside XWalk1?	N/A	N/A	Ramp inside XWalk2?	N/A
	Road Slope (%)	0.8	N/A	Clear Space?	N/A
	Road X Slope (%)	1.4	N/A	Clear Space to XWalk (in)	N/A
N/A	Any Obstructions?	N/A	N/A	Storm Grate/Utility Hazard?	N/A
	Obstruction Type			Storm Grate/Utility Type	
N/A					N/A
			Yes	Surface Condition? (G/P)	Good

Remove & Replace Curb Ramp With Two New Directional Ramps or Equivalent.
