Access Compliance Report
Public Rights-of-Way
(Curb Ramps)

Intersection ID: 3244 **Main Street:** CANTERBROOK_DR **Cross Street:** WORSLEY_LN **Location:** S

ADA ID: 3B0E90F18CDC **Ramp Type:** Perp **Initial Pass/Fail:** Fail **Overall Compliance:** No **Severity Score:** 10

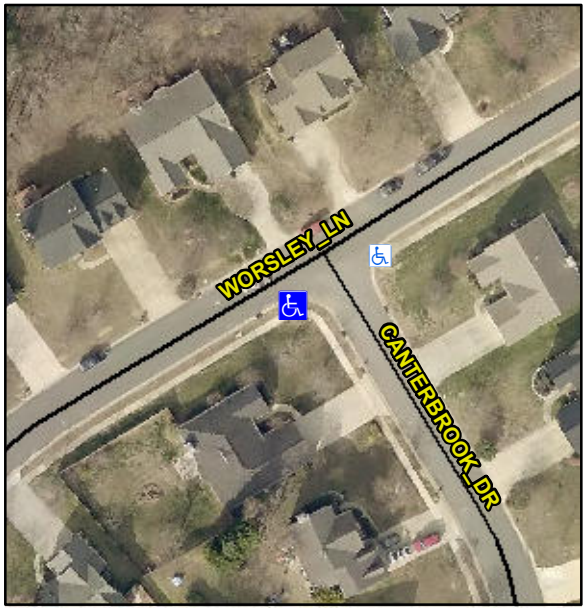
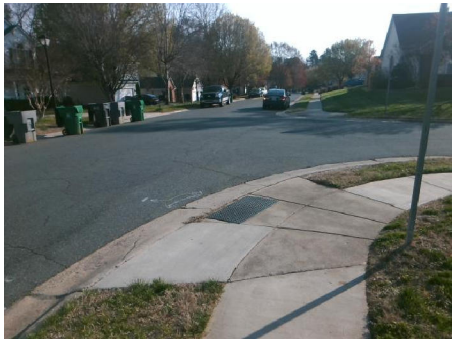
Not Found, R304.5.1, R304.5.3

Compliance	Description	Data	Compliance	Description	Data
N/A	Ramp Length (in)	44.0	Yes	Ramp Slope (%)	5.3
No	Ramp Width (in)	40.0	No	Ramp XSlope (%)	2.1
N/A	Flare Type LT	N/A	N/A	Flare Type RT	N/A
N/A	Flare Slope LT (%)	N/A	N/A	Flare Slope RT (%)	N/A
N/A	Flare Traversable LT?	N/A	N/A	Flare Traversable RT?	N/A
N/A	Landing Length (in)	N/A	N/A	DWS Provided?	N/A
N/A	Landing Width (in)	N/A	N/A	DWS Contrast?	N/A
N/A	Landing Slope (%)	N/A	N/A	DWS Length (in)	N/A
N/A	Landing X Slope (%)	N/A	N/A	DWS Full Width?	N/A
N/A	Landing Curb? (Y/N)	N/A	N/A	DWS Offset (in)	N/A
N/A	Shared Landing?	N/A			
N/A	Gutter Ponding?	N/A	N/A	Gutter Slope (%)	N/A
N/A	Gutter Lip Ht (in)	N/A	N/A	Gutter X Slope (%)	N/A
N/A	Painted X Walk1?	No	N/A	Painted X Walk2?	N/A
	X Walk 1 Direction	To E		X Walk 2 Direction	N/A
N/A	X Walk 1 Width (in)	N/A	N/A	X Walk 2 Width (in)	N/A
	X Walk 1 Slope (%)	2.9		X Walk 2 Slope (%)	N/A

Remove & Replace Entire Ramp.
