Access Compliance Report
Public Rights-of-Way
(Curb Ramps)

Intersection ID: 21503	Main Street: BLUEBERRY_LN	Cross Street: PROVIDENCE_RD	Location:	NW
ADA ID: 3B19259CB0BB	Ramp Type: PerpDiag	Initial Pass/Fail: Fail	Overall Compliance: No	Severity Score: 10

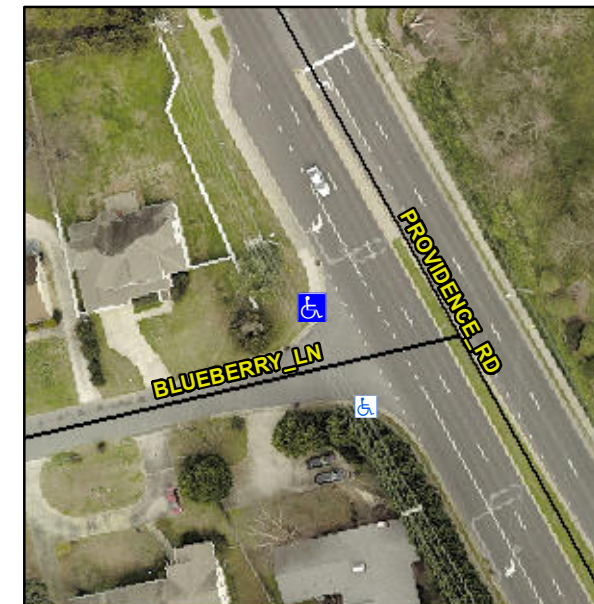
Not Found, R304.5.1, R304.5.3

Compliance	Description	Data	Compliance	Description	Data
N/A	Ramp Length (in)	72.0	Yes	Ramp Slope (%)	5.1
No	Ramp Width (in)	47.5	No	Ramp XSlope (%)	3.0
N/A	Flare Type LT	N/A	N/A	Flare Type RT	N/A
N/A	Flare Slope LT (%)	N/A	N/A	Flare Slope RT (%)	N/A
N/A	Flare Traversable LT?	N/A	N/A	Flare Traversable RT?	N/A
N/A	Landing Length (in)	N/A	N/A	DWS Provided?	N/A
N/A	Landing Width (in)	N/A	N/A	DWS Contrast?	N/A
N/A	Landing Slope (%)	N/A	N/A	DWS Length (in)	N/A
N/A	Landing X Slope (%)	N/A	N/A	DWS Full Width?	N/A
N/A	Landing Curb? (Y/N)	N/A	N/A	DWS Offset (in)	N/A
N/A	Shared Landing?	N/A			
N/A	Gutter Ponding?	N/A	N/A	Gutter Slope (%)	N/A
N/A	Gutter Lip Ht (in)	N/A	N/A	Gutter X Slope (%)	N/A
N/A	Painted X Walk1?	No	N/A	Painted X Walk2?	No
	X Walk 1 Direction	To S		X Walk 2 Direction	To E
N/A	X Walk 1 Width (in)	N/A	N/A	X Walk 2 Width (in)	N/A
	X Walk 1 Slope (%)	0.3		X Walk 2 Slope (%)	3.1
	X Walk 1 X Slope (%)	3.5		X Walk 2 X Slope (%)	1.7

Remove & Replace Curb Ramp With Two New Directional Ramps or Equivalent.
