Access Compliance Report
Public Rights-of-Way
(Curb Ramps)

Intersection ID: 17986 **Main Street:** E_INDEPENDENCE_BV **Cross Street:** DION_AV **Location:** SE

ADA ID: 3BBBE4924048 **Ramp Type:** PerpDiag **Initial Pass/Fail:** Fail **Overall Compliance:** No **Severity Score:** 22.5

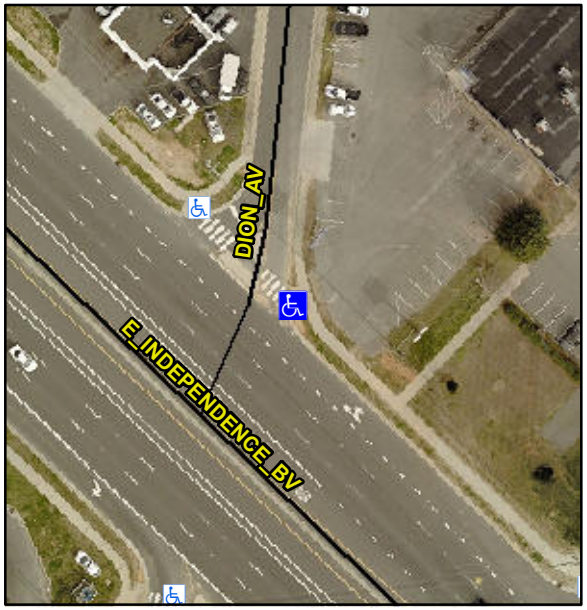
Not Found, R304.5.1, R304.2.2, R304.5.3

Compliance	Description	Data	Compliance	Description	Data
N/A	Ramp Length (in)	67.0	No	Ramp Slope (%)	8.8
No	Ramp Width (in)	47.0	No	Ramp XSlope (%)	2.9
N/A	Flare Type LT	N/A	N/A	Flare Type RT	N/A
N/A	Flare Slope LT (%)	N/A	N/A	Flare Slope RT (%)	N/A
N/A	Flare Traversable LT?	N/A	N/A	Flare Traversable RT?	N/A
N/A	Landing Length (in)	N/A	N/A	DWS Provided?	N/A
N/A	Landing Width (in)	N/A	N/A	DWS Contrast?	N/A
N/A	Landing Slope (%)	N/A	N/A	DWS Length (in)	N/A
N/A	Landing X Slope (%)	N/A	N/A	DWS Full Width?	N/A
N/A	Landing Curb? (Y/N)	N/A	N/A	DWS Offset (in)	N/A
N/A	Shared Landing?	N/A			
N/A	Gutter Ponding?	N/A	N/A	Gutter Slope (%)	N/A
N/A	Gutter Lip Ht (in)	N/A	N/A	Gutter X Slope (%)	N/A
N/A	Painted X Walk1?	Yes	N/A	Painted X Walk2?	No
	X Walk 1 Direction	To NW		X Walk 2 Direction	To SW
N/A	X Walk 1 Width (in)	108.0	N/A	X Walk 2 Width (in)	N/A
	X Walk 1 Slope (%)	2.8		X Walk 2 Slope (%)	2.0
	X Walk 1 X Slope (%)	0.8		X Walk 2 X Slope (%)	0.1

Remove & Replace Curb Ramp With Two New Directional Ramps or Equivalent.
