Access Compliance Report
Public Rights-of-Way
(Curb Ramps)

Intersection ID: 29768	**Main Street:** KNIGHT_CASTLE_DR	**Cross Street:** WILD_AZALEA_LN	**Location:** SW
ADA ID: 3BE2BF18BEA9	**Ramp Type:** PerpDiag	**Initial Pass/Fail:** Fail	**Overall Compliance:** No	**Severity Score:** 67.5

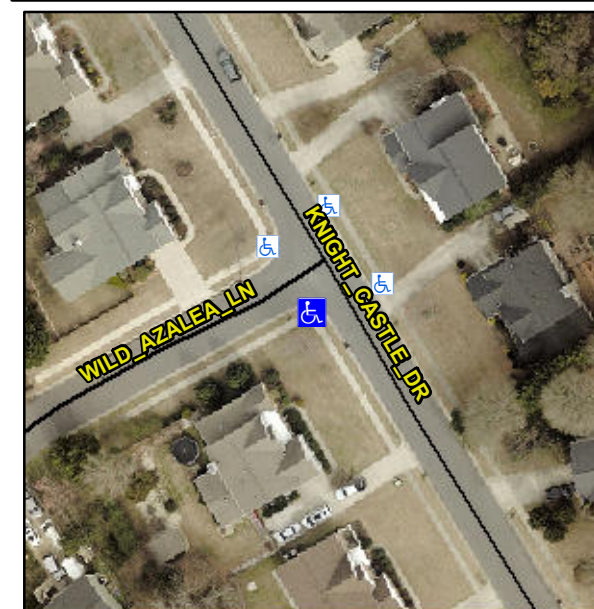
Not Found, R304.5.1, R304.2.2, R304.5.3

Compliance	Description	Data	Compliance	Description	Data
N/A	Ramp Length (in)	96.0	No	Ramp Slope (%)	12.4
No	Ramp Width (in)	35.0	No	Ramp XSlope (%)	9.3
N/A	Flare Type LT	N/A	N/A	Flare Type RT	N/A
N/A	Flare Slope LT (%)	N/A	N/A	Flare Slope RT (%)	N/A
N/A	Flare Traversable LT?	N/A	N/A	Flare Traversable RT?	N/A
N/A	Landing Length (in)	N/A	N/A	DWS Provided?	N/A
N/A	Landing Width (in)	N/A	N/A	DWS Contrast?	N/A
N/A	Landing Slope (%)	N/A	N/A	DWS Length (in)	N/A
N/A	Landing X Slope (%)	N/A	N/A	DWS Full Width?	N/A
N/A	Landing Curb? (Y/N)	N/A	N/A	DWS Offset (in)	N/A
N/A	Shared Landing?	N/A			
N/A	Gutter Ponding?	N/A	N/A	Gutter Slope (%)	N/A
N/A	Gutter Lip Ht (in)	N/A	N/A	Gutter X Slope (%)	N/A
N/A	Painted X Walk1?	No	N/A	Painted X Walk2?	No
	X Walk 1 Direction	To NE		X Walk 2 Direction	To E
N/A	X Walk 1 Width (in)	N/A	N/A	X Walk 2 Width (in)	N/A
	X Walk 1 Slope (%)	3.5		X Walk 2 Slope (%)	3.4
	X Walk 1 X Slope (%)	0.7		X Walk 2 X Slope (%)	0.5

Remove & Replace Curb Ramp With Two New Directional Ramps or Equivalent.
