# Access Compliance Report
Public Rights-of-Way
(Curb Ramps)

Intersection ID: 51536	Main Street: GLENBURN_LN	Cross Street: LOCHY_LN	Location:	NE
ADA ID: 3C3DFA4AD5BB	Ramp Type: BlendTrans1	Initial Pass/Fail: Fail	Overall Compliance: No	Severity Score: 10

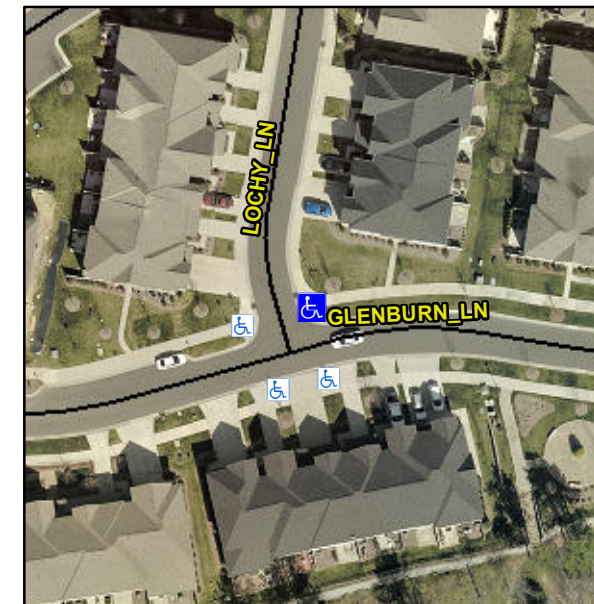
Not Found, R304.5.1, R304.5.3

Compliance	Description	Data	Compliance	Description	Data
N/A	Ramp Length (in)	82.0	Yes	BlendTrans Slope (%)	3.4
No	Ramp Width (in)	45.0	No	BlendTrans XSlope (%)	2.4
N/A	Flare Type LT	N/A	N/A	Flare Type RT	N/A
N/A	Flare Slope LT (%)	N/A	N/A	Flare Slope RT (%)	N/A
N/A	Flare Traversable LT?	N/A	N/A	Flare Traversable RT?	N/A
N/A	Landing Length (in)	N/A	N/A	DWS Provided?	N/A
N/A	Landing Width (in)	N/A	N/A	DWS Contrast?	N/A
N/A	Landing Slope (%)	N/A	N/A	DWS Length (in)	N/A
N/A	Landing X Slope (%)	N/A	N/A	DWS Full Width?	N/A
N/A	Landing Curb? (Y/N)	N/A	N/A	DWS Offset (in)	N/A
N/A	Shared Landing?	N/A			
N/A	Gutter Ponding?	N/A	N/A	Gutter Slope (%)	N/A
N/A	Gutter Lip Ht (in)	N/A	N/A	Gutter X Slope (%)	N/A
N/A	Painted X Walk1?	No	N/A	Painted X Walk2?	No
	X Walk 1 Direction	To W		X Walk 2 Direction	To S
	X Walk 1 Width (in)	N/A		X Walk 2 Width (in)	N/A
	X Walk 1 Slope (%)	1.4		X Walk 2 Slope (%)	2.7
	X Walk 1 X Slope (%)	4.4		X Walk 2 X Slope (%)	0.1

N/A	Ramp inside XWalk1?	N/A	N/A	Ramp inside XWalk2?	N/A
	Road Slope (%)	3.3		Clear Space?	N/A
	Road X Slope (%)	3.1	N/A	Clear Space to XWalk (in)	N/A
N/A	Any Obstructions?	N/A	N/A	Storm Grate/Utility Hazard?	N/A
	Obstruction Type			Storm Grate/Utility Type	
N/A					N/A
			Yes	Surface Condition? (G/P)	Good
			No	Curb Slope (%)	7.9

Remove & Replace Curb Ramp With Two New Directional Ramps or Equivalent.
