Access Compliance Report
Public Rights-of-Way
(Curb Ramps)

Intersection ID: 48493	Main Street: **NEWTONMORE_DR**	Cross Street: **BEREWICK_COMMONS_PY**	Location:	**SW**
ADA ID: 3C5812EB1122	Ramp Type: **Perp**	Initial Pass/Fail: **Fail**	Overall Compliance: **No**	Severity Score: **22.5**

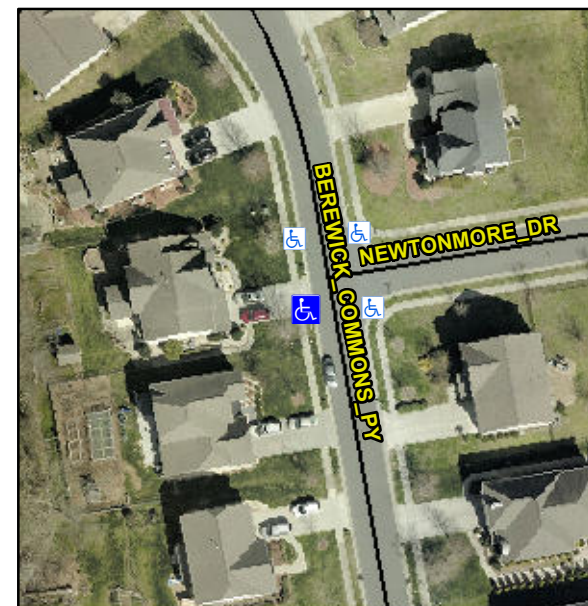
R304.5.1, R304.2.2, R304.5.3

Compliance	Description	Data	Compliance	Description	Data
N/A	Ramp Length (in)	48.0	No	Ramp Slope (%)	9.2
No	Ramp Width (in)	47.5	No	Ramp XSlope (%)	2.8
N/A	Flare Type LT	N/A	N/A	Flare Type RT	N/A
N/A	Flare Slope LT (%)	N/A	N/A	Flare Slope RT (%)	N/A
N/A	Flare Traversable LT?	N/A	N/A	Flare Traversable RT?	N/A
N/A	Landing Length (in)	N/A	N/A	DWS Provided?	N/A
N/A	Landing Width (in)	N/A	N/A	DWS Contrast?	N/A
N/A	Landing Slope (%)	N/A	N/A	DWS Length (in)	N/A
N/A	Landing X Slope (%)	N/A	N/A	DWS Full Width?	N/A
N/A	Landing Curb? (Y/N)	N/A	N/A	DWS Offset (in)	N/A
N/A	Shared Landing?	N/A			
N/A	Gutter Ponding?	N/A	N/A	Gutter Slope (%)	N/A
N/A	Gutter Lip Ht (in)	N/A	N/A	Gutter X Slope (%)	N/A
N/A	Painted X Walk1?	No	N/A	Painted X Walk2?	N/A
	X Walk 1 Direction	To E		X Walk 2 Direction	N/A
N/A	X Walk 1 Width (in)	N/A	N/A	X Walk 2 Width (in)	N/A
	X Walk 1 Slope (%)	2.1		X Walk 2 Slope (%)	N/A
	X Walk 1 X Slope (%)	2.2		X Walk 2 X Slope (%)	N/A

Remove & Replace Entire Ramp.
