Access Compliance Report
Public Rights-of-Way
(Curb Ramps)

Intersection ID: 27495 **Main Street:** BALLANTYNE_COMMONS_PY **Cross Street:** NORTH_COMMUNITY_HOUSE_RD **Location:** NW

ADA ID: 3C7DD1A2AAE3 **Ramp Type:** Perp **Initial Pass/Fail:** Fail **Overall Compliance:** No **Severity Score:** 21.25

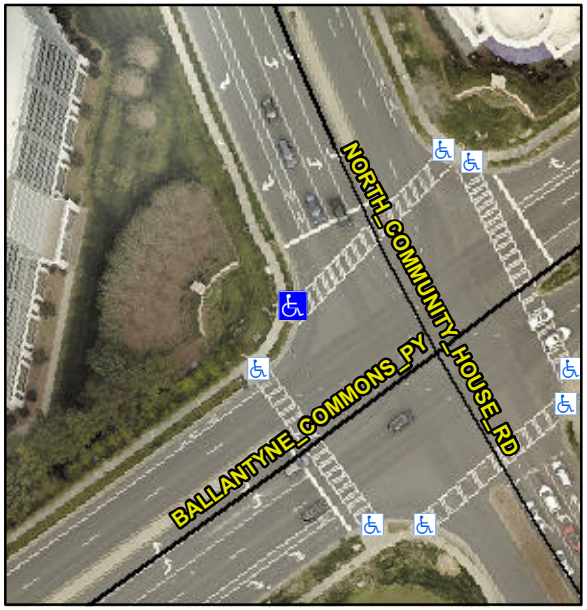
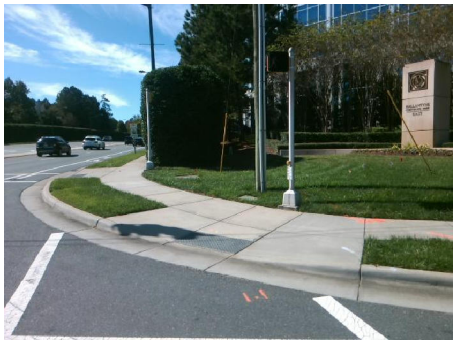
R304.5.1, R304.5.3

Compliance	Description	Data	Compliance	Description	Data
N/A	Ramp Length (in)	111.5	Yes	Ramp Slope (%)	5.0
No	Ramp Width (in)	47.5	No	Ramp XSlope (%)	5.4
N/A	Flare Type LT	N/A	N/A	Flare Type RT	N/A
N/A	Flare Slope LT (%)	N/A	N/A	Flare Slope RT (%)	N/A
N/A	Flare Traversable LT?	N/A	N/A	Flare Traversable RT?	N/A
N/A	Landing Length (in)	N/A	N/A	DWS Provided?	N/A
N/A	Landing Width (in)	N/A	N/A	DWS Contrast?	N/A
N/A	Landing Slope (%)	N/A	N/A	DWS Length (in)	N/A
N/A	Landing X Slope (%)	N/A	N/A	DWS Full Width?	N/A
N/A	Landing Curb? (Y/N)	N/A	N/A	DWS Offset (in)	N/A
N/A	Shared Landing?	N/A			
N/A	Gutter Ponding?	N/A	N/A	Gutter Slope (%)	N/A
N/A	Gutter Lip Ht (in)	N/A	N/A	Gutter X Slope (%)	N/A
N/A	Painted X Walk1?	Yes	N/A	Painted X Walk2?	N/A
	X Walk 1 Direction	To NE		X Walk 2 Direction	N/A
N/A	X Walk 1 Width (in)	127.0	N/A	X Walk 2 Width (in)	N/A
	X Walk 1 Slope (%)	3.6		X Walk 2 Slope (%)	N/A

Remove & Replace Entire Ramp.
