Access Compliance Report
Public Rights-of-Way
(Curb Ramps)

Intersection ID: 48696	Main Street: MONTGOMERY_GARDENS_DR	Cross Street: BEATTIES_FORD_RD	Location:	E
ADA ID: 3E67E68B91DE	Ramp Type: PerpDiag	Initial Pass/Fail: Fail	Overall Compliance: No	Severity Score: 21.25

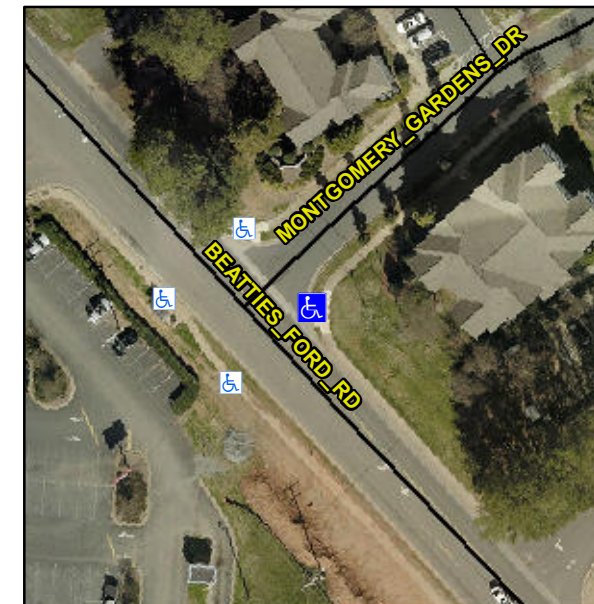
Not Found, R304.5.1, R304.2.2

Compliance	Description	Data	Compliance	Description	Data
N/A	Ramp Length (in)	48.0	No	Ramp Slope (%)	8.5
No	Ramp Width (in)	45.0	Yes	Ramp XSlope (%)	1.9
N/A	Flare Type LT	N/A	N/A	Flare Type RT	N/A
N/A	Flare Slope LT (%)	N/A	N/A	Flare Slope RT (%)	N/A
N/A	Flare Traversable LT?	N/A	N/A	Flare Traversable RT?	N/A
N/A	Landing Length (in)	N/A	N/A	DWS Provided?	N/A
N/A	Landing Width (in)	N/A	N/A	DWS Contrast?	N/A
N/A	Landing Slope (%)	N/A	N/A	DWS Length (in)	N/A
N/A	Landing X Slope (%)	N/A	N/A	DWS Full Width?	N/A
N/A	Landing Curb? (Y/N)	N/A	N/A	DWS Offset (in)	N/A
N/A	Shared Landing?	N/A			
N/A	Gutter Ponding?	N/A	N/A	Gutter Slope (%)	N/A
N/A	Gutter Lip Ht (in)	N/A	N/A	Gutter X Slope (%)	N/A
N/A	Painted X Walk1?	No	N/A	Painted X Walk2?	No
	X Walk 1 Direction	To NW		X Walk 2 Direction	To SW
N/A	X Walk 1 Width (in)	N/A	N/A	X Walk 2 Width (in)	N/A
	X Walk 1 Slope (%)	0.1		X Walk 2 Slope (%)	2.3
	X Walk 1 X Slope (%)	3.2		X Walk 2 X Slope (%)	0.8

Remove & Replace Curb Ramp With Two New Directional Ramps or Equivalent.
