Access Compliance Report
Public Rights-of-Way
(Curb Ramps)

Intersection ID: 21898	Main Street: FOUNTAINHILL_RIDGE_RD	Cross Street: MILL_POND_RD	Location:	S
ADA ID: 3EE78C64BCF9	Ramp Type: PerpDiag	Initial Pass/Fail: Fail	Overall Compliance: No	Severity Score: 25

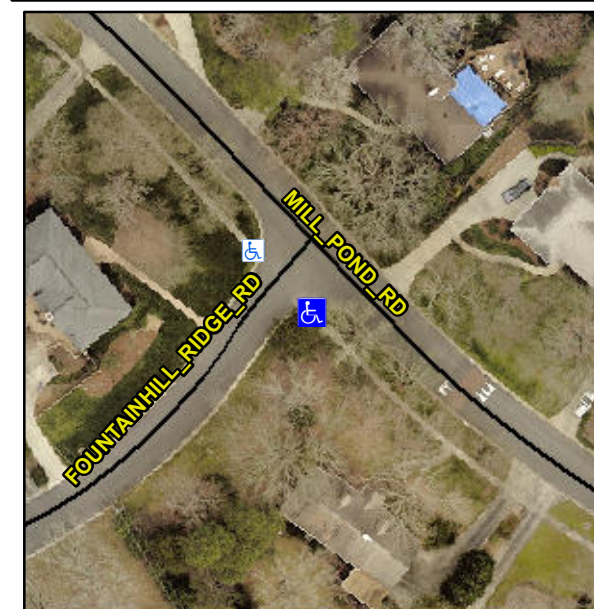
Not Found, R304.2.2

Compliance	Description	Data	Compliance	Description	Data
N/A	Ramp Length (in)	94.0	No	Ramp Slope (%)	13.2
Yes	Ramp Width (in)	48.0	Yes	Ramp XSlope (%)	1.8
N/A	Flare Type LT	N/A	N/A	Flare Type RT	N/A
N/A	Flare Slope LT (%)	N/A	N/A	Flare Slope RT (%)	N/A
N/A	Flare Traversable LT?	N/A	N/A	Flare Traversable RT?	N/A
N/A	Landing Length (in)	N/A	N/A	DWS Provided?	N/A
N/A	Landing Width (in)	N/A	N/A	DWS Contrast?	N/A
N/A	Landing Slope (%)	N/A	N/A	DWS Length (in)	N/A
N/A	Landing X Slope (%)	N/A	N/A	DWS Full Width?	N/A
N/A	Landing Curb? (Y/N)	N/A	N/A	DWS Offset (in)	N/A
N/A	Shared Landing?	N/A			
N/A	Gutter Ponding?	N/A	N/A	Gutter Slope (%)	N/A
N/A	Gutter Lip Ht (in)	N/A	N/A	Gutter X Slope (%)	N/A
N/A	Painted X Walk1?	No	N/A	Painted X Walk2?	No
	X Walk 1 Direction	To NE		X Walk 2 Direction	To NW
N/A	X Walk 1 Width (in)	N/A	N/A	X Walk 2 Width (in)	N/A
	X Walk 1 Slope (%)	4.3		X Walk 2 Slope (%)	4.3
	X Walk 1 X Slope (%)	6.9		X Walk 2 X Slope (%)	2.2

Remove & Replace Curb Ramp With Two New Directional Ramps or Equivalent.
