# Access Compliance Report
Public Rights-of-Way
(Curb Ramps)

Intersection ID: 14314	Main Street: E_TREMONT_AV	Cross Street: SOUTH_BV	Location: NE
ADA ID: 3EF13556D1CB	Ramp Type: Perp	Initial Pass/Fail: Fail	Overall Compliance: No	Severity Score: 13.75

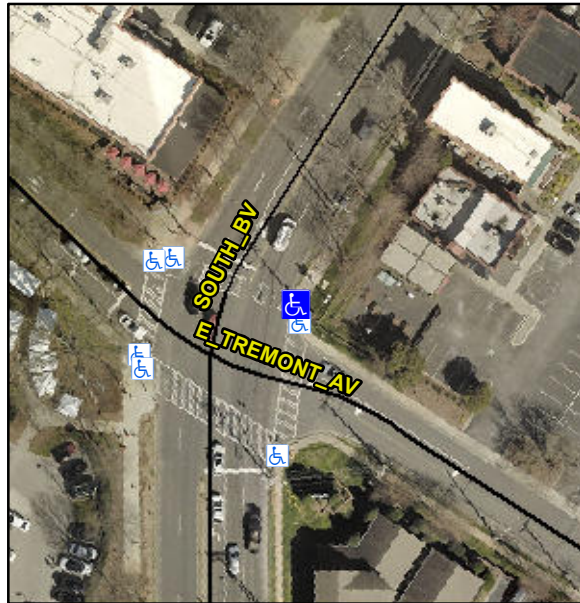
R304.2.2, R304.5.3

Compliance	Description	Data	Compliance	Description	Data
N/A	Ramp Length (in)	60.0	No	Ramp Slope (%)	9.6
Yes	Ramp Width (in)	48.0	No	Ramp XSlope (%)	2.8
N/A	Flare Type LT	N/A	N/A	Flare Type RT	N/A
N/A	Flare Slope LT (%)	N/A	N/A	Flare Slope RT (%)	N/A
N/A	Flare Traversable LT?	N/A	N/A	Flare Traversable RT?	N/A
N/A	Landing Length (in)	N/A	N/A	DWS Provided?	N/A
N/A	Landing Width (in)	N/A	N/A	DWS Contrast?	N/A
N/A	Landing Slope (%)	N/A	N/A	DWS Length (in)	N/A
N/A	Landing X Slope (%)	N/A	N/A	DWS Full Width?	N/A
N/A	Landing Curb? (Y/N)	N/A	N/A	DWS Offset (in)	N/A
N/A	Shared Landing?	N/A			
N/A	Gutter Ponding?	N/A	N/A	Gutter Slope (%)	N/A
N/A	Gutter Lip Ht (in)	N/A	N/A	Gutter X Slope (%)	N/A
N/A	Painted X Walk1?	Yes	N/A	Painted X Walk2?	N/A
	X Walk 1 Direction	To NW		X Walk 2 Direction	N/A
N/A	X Walk 1 Width (in)	113.0	N/A	X Walk 2 Width (in)	N/A
	X Walk 1 Slope (%)	4.8		X Walk 2 Slope (%)	N/A
	X Walk 1 X Slope (%)	1.0		X Walk 2 X Slope (%)	N/A

N/A	Ramp inside XWalk1?	Yes	N/A	Ramp inside XWalk2?	N/A
	Road Slope (%)	N/A	N/A	Clear Space?	N/A
	Road X Slope (%)	N/A	N/A	Clear Space to XWalk (in)	N/A
N/A	Any Obstructions?	N/A	N/A	Storm Grate/Utility Hazard?	N/A
	Obstruction Type			Storm Grate/Utility Type	
N/A					N/A
			Yes	Surface Condition? (G/P)	Good

Remove & Replace Entire Ramp.
