Access Compliance Report
Public Rights-of-Way
(Curb Ramps)

Intersection ID: 10039270	**Main Street:** SUNSET_RD	**Cross Street:** N/A	**Location:**	**NW**
ADA ID: 3F10C76EBE6D	**Ramp Type:** Perp	**Initial Pass/Fail:** Pass	**Overall Compliance:** No	**Severity Score:** 0.25

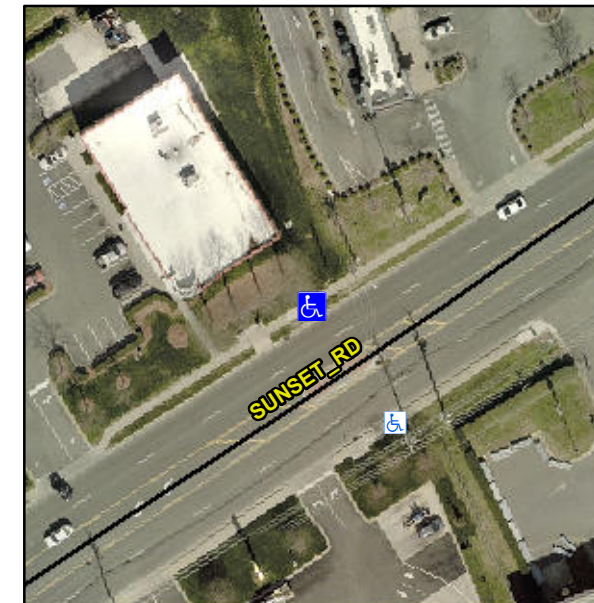
Not Found, R304.5.3

Compliance	Description	Data	Compliance	Description	Data
N/A	Ramp Length (in)	55.0	Yes	Ramp Slope (%)	5.3
Yes	Ramp Width (in)	58.0	No	Ramp XSlope (%)	2.2
Yes	Flare Type LT	Curbed_NoWalkSurface	Yes	Flare Type RT	N/A
Yes	Flare Slope LT (%)	N/A	N/A	Flare Slope RT (%)	N/A
N/A	Flare Traversable LT?	No	N/A	Flare Traversable RT?	No
Yes	Landing Length (in)	60.0	Yes	DWS Provided?	Yes
Yes	Landing Width (in)	58.0	Yes	DWS Contrast?	Yes
Yes	Landing Slope (%)	1.8	Yes	DWS Length (in)	24.0
Yes	Landing X Slope (%)	0.3	Yes	DWS Full Width?	Yes
N/A	Landing Curb? (Y/N)	Yes	Yes	DWS Offset (in)	0.0
N/A	Shared Landing?	No			
Yes	Gutter Ponding?	No	Yes	Gutter Slope (%)	2.5
Yes	Gutter Lip Ht (in)	0.0	No	Gutter X Slope (%)	2.6
N/A	Painted X Walk1?	No	N/A	Painted X Walk2?	N/A
	X Walk 1 Direction	To SE		X Walk 2 Direction	N/A
N/A	X Walk 1 Width (in)	N/A	N/A	X Walk 2 Width (in)	N/A
	X Walk 1 Slope (%)	0.6		X Walk 2 Slope (%)	N/A
	X Walk 1 X Slope (%)	1.6		X Walk 2 X Slope (%)	N/A

N/A	Ramp inside XWalk1?	N/A	N/A	Ramp inside XWalk2?	N/A
	Road Slope (%)	N/A	N/A	Clear Space?	Yes
	Road X Slope (%)	N/A	N/A	Clear Space to XWalk (in)	N/A
Yes	Any Obstructions?	No	Yes	Storm Grate/Utility Hazard?	No
	Obstruction Type			Storm Grate/Utility Type	
		N/A			N/A
			Yes	Surface Condition? (G/P)	Good

Remove & Replace Entire Ramp.
Remove & Replace Gutter.
