Access Compliance Report
Public Rights-of-Way
(Curb Ramps)

Intersection ID: 47691	**Main Street:** GLENOLDEN_DR	**Cross Street:** GREEN_PASTURE_RD	**Location:** N
ADA ID: 3F5F14143452	**Ramp Type:** PerpDiag	**Initial Pass/Fail:** Fail	**Overall Compliance:** No **Severity Score:** 8.75

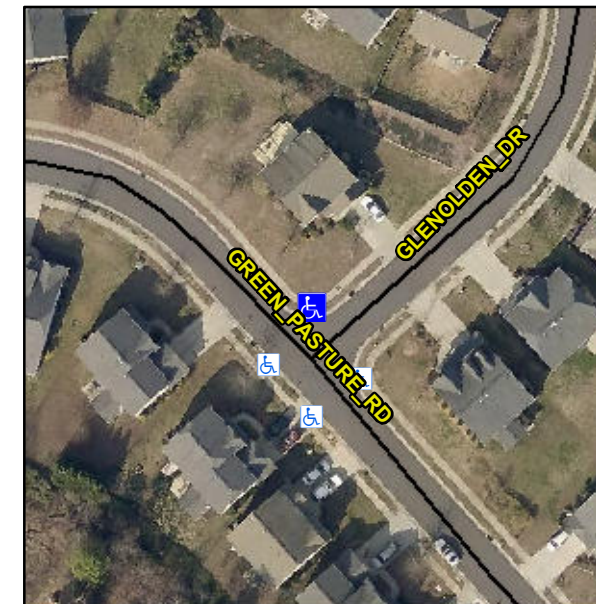
Not Found, R304.5.1

Compliance	Description	Data	Compliance	Description	Data
N/A	Ramp Length (in)	50.0	Yes	Ramp Slope (%)	7.1
No	Ramp Width (in)	47.0	Yes	Ramp XSlope (%)	1.4
N/A	Flare Type LT	N/A	N/A	Flare Type RT	N/A
N/A	Flare Slope LT (%)	N/A	N/A	Flare Slope RT (%)	N/A
N/A	Flare Traversable LT?	N/A	N/A	Flare Traversable RT?	N/A
N/A	Landing Length (in)	N/A	N/A	DWS Provided?	N/A
N/A	Landing Width (in)	N/A	N/A	DWS Contrast?	N/A
N/A	Landing Slope (%)	N/A	N/A	DWS Length (in)	N/A
N/A	Landing X Slope (%)	N/A	N/A	DWS Full Width?	N/A
N/A	Landing Curb? (Y/N)	N/A	N/A	DWS Offset (in)	N/A
N/A	Shared Landing?	N/A			
N/A	Gutter Ponding?	N/A	N/A	Gutter Slope (%)	N/A
N/A	Gutter Lip Ht (in)	N/A	N/A	Gutter X Slope (%)	N/A
N/A	Painted X Walk1?	No	N/A	Painted X Walk2?	No
	X Walk 1 Direction	To SW		X Walk 2 Direction	To SE
N/A	X Walk 1 Width (in)	N/A	N/A	X Walk 2 Width (in)	N/A
	X Walk 1 Slope (%)	0.6		X Walk 2 Slope (%)	0.6
	X Walk 1 X Slope (%)	0.2		X Walk 2 X Slope (%)	1.4

Remove & Replace Curb Ramp With Two New Directional Ramps or Equivalent.
