Access Compliance Report
Public Rights-of-Way
(Curb Ramps)

Intersection ID: 27411	Main Street: BALLANTYNE_COMMONS_PY	Cross Street: BALLANTYNE_CORPORATE_PL	Location:	NE
ADA ID: 3FEE1A887ECF	Ramp Type: Perp	Initial Pass/Fail: Fail	Overall Compliance: No	Severity Score: 13.75

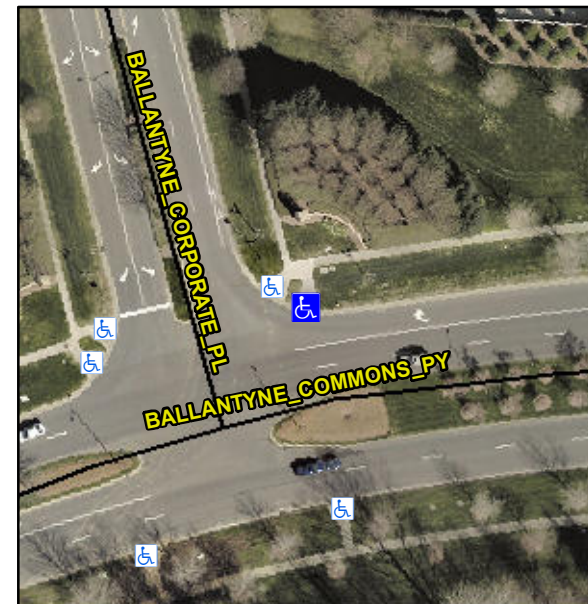
Not Found, R304.2.2, R304.5.3

Compliance	Description	Data	Compliance	Description	Data
N/A	Ramp Length (in)	125.5	No	Ramp Slope (%)	8.4
Yes	Ramp Width (in)	48.0	No	Ramp XSlope (%)	3.4
N/A	Flare Type LT	N/A	N/A	Flare Type RT	N/A
N/A	Flare Slope LT (%)	N/A	N/A	Flare Slope RT (%)	N/A
N/A	Flare Traversable LT?	N/A	N/A	Flare Traversable RT?	N/A
N/A	Landing Length (in)	N/A	N/A	DWS Provided?	N/A
N/A	Landing Width (in)	N/A	N/A	DWS Contrast?	N/A
N/A	Landing Slope (%)	N/A	N/A	DWS Length (in)	N/A
N/A	Landing X Slope (%)	N/A	N/A	DWS Full Width?	N/A
N/A	Landing Curb? (Y/N)	N/A	N/A	DWS Offset (in)	N/A
N/A	Shared Landing?	N/A			
N/A	Gutter Ponding?	N/A	N/A	Gutter Slope (%)	N/A
N/A	Gutter Lip Ht (in)	N/A	N/A	Gutter X Slope (%)	N/A
N/A	Painted X Walk1?	No	N/A	Painted X Walk2?	N/A
	X Walk 1 Direction	To S		X Walk 2 Direction	N/A
N/A	X Walk 1 Width (in)	N/A	N/A	X Walk 2 Width (in)	N/A
	X Walk 1 Slope (%)	2.3		X Walk 2 Slope (%)	N/A
	X Walk 1 X Slope (%)	2.2		X Walk 2 X Slope (%)	N/A

Remove & Replace Entire Ramp.
