Access Compliance Report
Public Rights-of-Way
(Curb Ramps)

Intersection ID: 9768	Main Street: EASTWAY_DR	Cross Street: THE_PLAZA	Location:	NW
ADA ID: 401CD9FCB566	Ramp Type: PerpDiag	Initial Pass/Fail: Fail	Overall Compliance: No	Severity Score: 22.5

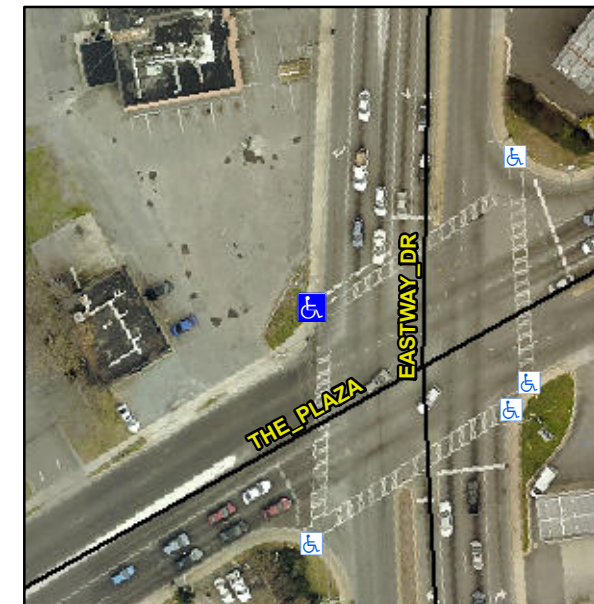
Not Found, R304.5.1, R304.2.2, R304.5.3

Compliance	Description	Data	Compliance	Description	Data
N/A	Ramp Length (in)	62.0	No	Ramp Slope (%)	10.0
No	Ramp Width (in)	43.0	No	Ramp XSlope (%)	3.0
N/A	Flare Type LT	N/A	N/A	Flare Type RT	N/A
N/A	Flare Slope LT (%)	N/A	N/A	Flare Slope RT (%)	N/A
N/A	Flare Traversable LT?	N/A	N/A	Flare Traversable RT?	N/A
N/A	Landing Length (in)	N/A	N/A	DWS Provided?	N/A
N/A	Landing Width (in)	N/A	N/A	DWS Contrast?	N/A
N/A	Landing Slope (%)	N/A	N/A	DWS Length (in)	N/A
N/A	Landing X Slope (%)	N/A	N/A	DWS Full Width?	N/A
N/A	Landing Curb? (Y/N)	N/A	N/A	DWS Offset (in)	N/A
N/A	Shared Landing?	N/A			
N/A	Gutter Ponding?	N/A	N/A	Gutter Slope (%)	N/A
N/A	Gutter Lip Ht (in)	N/A	N/A	Gutter X Slope (%)	N/A
N/A	Painted X Walk1?	Yes	N/A	Painted X Walk2?	Yes
	X Walk 1 Direction	To SW		X Walk 2 Direction	To NE
N/A	X Walk 1 Width (in)	73.0	N/A	X Walk 2 Width (in)	57.0
	X Walk 1 Slope (%)	0.6		X Walk 2 Slope (%)	0.9
	X Walk 1 X Slope (%)	1.4		X Walk 2 X Slope (%)	1.3

Remove & Replace Curb Ramp With Two New Directional Ramps or Equivalent.
