Access Compliance Report

# Public Rights-of-Way
(Curb Ramps)

Intersection ID: 47842	**Main Street:** MANITOBA_LN	**Cross Street:** CACTUS_VALLEY_RD	**Location:**	**SW**
ADA ID: 410C0B2F7A36	**Ramp Type:** Perp	**Initial Pass/Fail:** Fail	**Overall Compliance:** No	**Severity Score:** 12.5

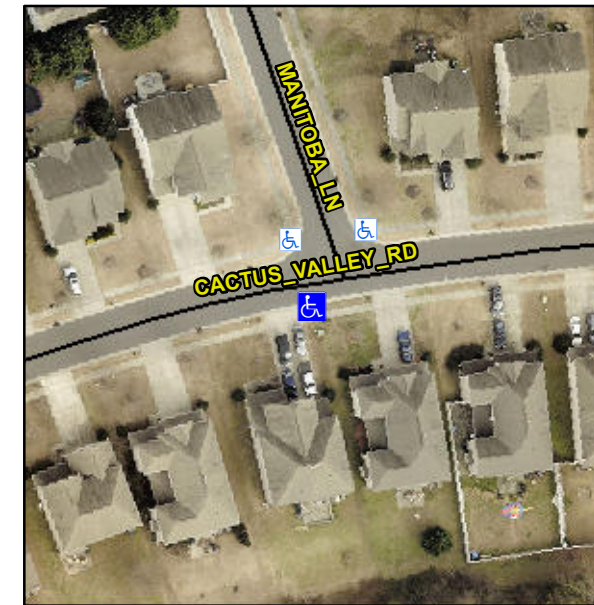
R304.2.2

Compliance	Description	Data	Compliance	Description	Data
N/A	Ramp Length (in)	48.0	No	Ramp Slope (%)	10.7
Yes	Ramp Width (in)	48.0	Yes	Ramp XSlope (%)	1.2
N/A	Flare Type LT	N/A	N/A	Flare Type RT	N/A
N/A	Flare Slope LT (%)	N/A	N/A	Flare Slope RT (%)	N/A
N/A	Flare Traversable LT?	N/A	N/A	Flare Traversable RT?	N/A
N/A	Landing Length (in)	N/A	N/A	DWS Provided?	N/A
N/A	Landing Width (in)	N/A	N/A	DWS Contrast?	N/A
N/A	Landing Slope (%)	N/A	N/A	DWS Length (in)	N/A
N/A	Landing X Slope (%)	N/A	N/A	DWS Full Width?	N/A
N/A	Landing Curb? (Y/N)	N/A	N/A	DWS Offset (in)	N/A
N/A	Shared Landing?	N/A			
N/A	Gutter Ponding?	N/A	N/A	Gutter Slope (%)	N/A
N/A	Gutter Lip Ht (in)	N/A	N/A	Gutter X Slope (%)	N/A
N/A	Painted X Walk1?	No	N/A	Painted X Walk2?	N/A
	X Walk 1 Direction	To NW		X Walk 2 Direction	N/A
N/A	X Walk 1 Width (in)	N/A	N/A	X Walk 2 Width (in)	N/A
	X Walk 1 Slope (%)	1.6		X Walk 2 Slope (%)	N/A
	X Walk 1 X Slope (%)	1.7		X Walk 2 X Slope (%)	N/A

Remove & Replace Entire Ramp.
