Access Compliance Report

# Public Rights-of-Way
(Curb Ramps)

Intersection ID: 12968	**Main Street:** LINCOLN_ST	**Cross Street:** S_MINT_ST	**Location:** E
ADA ID: 423CCBDDD28E	**Ramp Type:** PerpDiag	**Initial Pass/Fail:** Fail **Overall Compliance:** No	**Severity Score:** 26.25

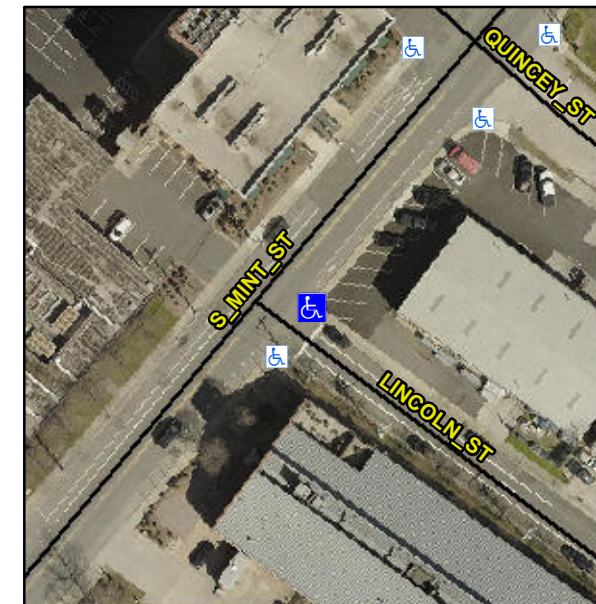
Not Found, R304.2.2, R304.5.3

Compliance	Description	Data	Compliance	Description	Data
N/A	Ramp Length (in)	47.0	No	Ramp Slope (%)	12.5
Yes	Ramp Width (in)	48.0	No	Ramp XSlope (%)	2.1
N/A	Flare Type LT	N/A	N/A	Flare Type RT	N/A
N/A	Flare Slope LT (%)	N/A	N/A	Flare Slope RT (%)	N/A
N/A	Flare Traversable LT?	N/A	N/A	Flare Traversable RT?	N/A
N/A	Landing Length (in)	N/A	N/A	DWS Provided?	N/A
N/A	Landing Width (in)	N/A	N/A	DWS Contrast?	N/A
N/A	Landing Slope (%)	N/A	N/A	DWS Length (in)	N/A
N/A	Landing X Slope (%)	N/A	N/A	DWS Full Width?	N/A
N/A	Landing Curb? (Y/N)	N/A	N/A	DWS Offset (in)	N/A
N/A	Shared Landing?	N/A			
N/A	Gutter Ponding?	N/A	N/A	Gutter Slope (%)	N/A
N/A	Gutter Lip Ht (in)	N/A	N/A	Gutter X Slope (%)	N/A
N/A	Painted X Walk1?	No	N/A	Painted X Walk2?	No
	X Walk 1 Direction	To NW		X Walk 2 Direction	To SW
N/A	X Walk 1 Width (in)	N/A	N/A	X Walk 2 Width (in)	N/A
	X Walk 1 Slope (%)	5.3		X Walk 2 Slope (%)	3.6
	X Walk 1 X Slope (%)	1.1		X Walk 2 X Slope (%)	1.6

Remove & Replace Curb Ramp With Two New Directional Ramps or Equivalent.
