Access Compliance Report
Public Rights-of-Way
(Curb Ramps)

Intersection ID: 50938	Main Street: BLAIRBETH_ST	Cross Street: CANMORE_ST	Location:	NW
ADA ID: 424BD9BE7715	Ramp Type: PerpDiag	Initial Pass/Fail: Fail	Overall Compliance: No	Severity Score: 13.75

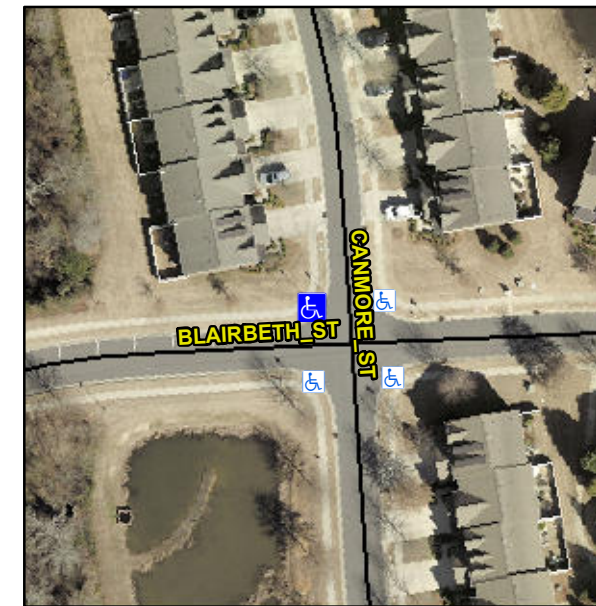
Not Found, R304.2.2, R304.5.3

Remove & Replace Curb Ramp With Two New Directional Ramps or Equivalent.
