Access Compliance Report
Public Rights-of-Way
(Curb Ramps)

Intersection ID: 24385	Main Street: BEVERLY_CREST_BV	Cross Street: BECKMORE_PL	Location:	NW
ADA ID: 433A58026269	Ramp Type: Combination1Diag	Initial Pass/Fail: Fail	Overall Compliance: No	Severity Score: 0

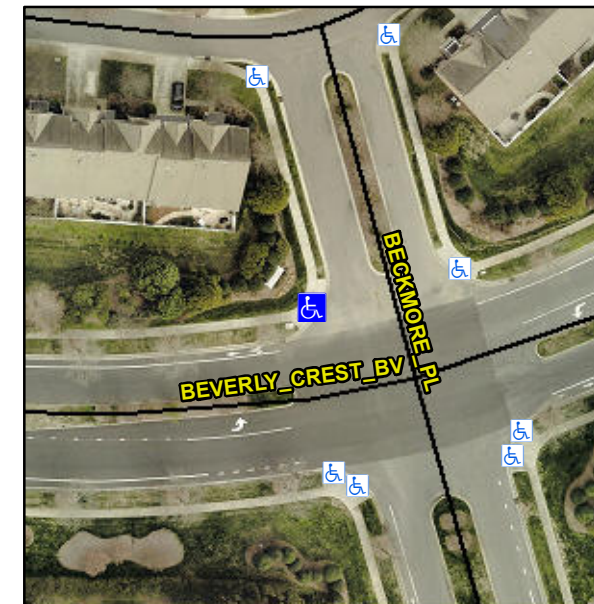
RP & RT RP < 5%

Not Found, R304.3.2, R304.5.3

Compliance	Description	Data	Compliance	Description	Data
N/A	Ramp Length LT (in)	48.0	N/A	Ramp Length RT (in)	54.5
Yes	Ramp Width LT (in)	58.5	Yes	Ramp Width RT (in)	59.0
No	Ramp Slope LT (%)	8.5	Yes	Ramp Slope RT (%)	0.3
No	Ramp XSlope LT (%)	5.2	No	Ramp XSlope RT (%)	3.9
N/A	Ramp Length (in)	48.0	Yes	Ramp Slope (%)	7.0
Yes	Ramp Width (in)	57.0	Yes	Ramp XSlope (%)	0.3
N/A	Flare Type LT	N/A	N/A	Flare Type RT	N/A
N/A	Flare Slope LT (%)	N/A	N/A	Flare Slope RT (%)	N/A
N/A	Flare Traversable LT?	N/A	N/A	Flare Traversable RT?	N/A
N/A	Landing Length (in)	N/A	N/A	DWS Provided?	N/A
N/A	Landing Width (in)	N/A	N/A	DWS Contrast?	N/A
N/A	Landing Slope (%)	N/A	N/A	DWS Length (in)	N/A
N/A	Landing X Slope (%)	N/A	N/A	DWS Full Width?	N/A
N/A	Landing Curb? (Y/N)	N/A	N/A	DWS Offset (in)	N/A
N/A	Shared Landing?	N/A			
N/A	Gutter Ponding?	N/A	N/A	Gutter Slope (%)	N/A
N/A	Gutter Lip Ht (in)	N/A	N/A	Gutter X Slope (%)	N/A
N/A	Painted X Walk1?	No	N/A	Painted X Walk2?	No

Remove & Replace Curb Ramp With Two New Directional Ramps or Equivalent. Remove & Replace Sidewalk.
