Access Compliance Report
Public Rights-of-Way
(Curb Ramps)

Intersection ID: 16738	Main Street: BEVERLY_DR	Cross Street: SHERWOOD_AV	Location:	NW
ADA ID: 44270978B360	Ramp Type: PerpDiag	Initial Pass/Fail: Fail	Overall Compliance: No	Severity Score: 35

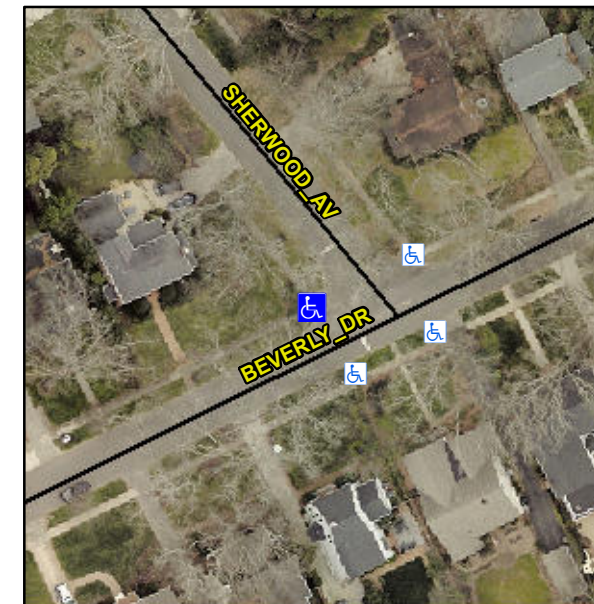
Not Found, R304.5.1, R304.2.2, R304.5.3

Compliance	Description	Data	Compliance	Description	Data
N/A	Ramp Length (in)	74.0	No	Ramp Slope (%)	12.9
No	Ramp Width (in)	43.0	No	Ramp XSlope (%)	2.7
N/A	Flare Type LT	N/A	N/A	Flare Type RT	N/A
N/A	Flare Slope LT (%)	N/A	N/A	Flare Slope RT (%)	N/A
N/A	Flare Traversable LT?	N/A	N/A	Flare Traversable RT?	N/A
N/A	Landing Length (in)	N/A	N/A	DWS Provided?	N/A
N/A	Landing Width (in)	N/A	N/A	DWS Contrast?	N/A
N/A	Landing Slope (%)	N/A	N/A	DWS Length (in)	N/A
N/A	Landing X Slope (%)	N/A	N/A	DWS Full Width?	N/A
N/A	Landing Curb? (Y/N)	N/A	N/A	DWS Offset (in)	N/A
N/A	Shared Landing?	N/A			
N/A	Gutter Ponding?	N/A	N/A	Gutter Slope (%)	N/A
N/A	Gutter Lip Ht (in)	N/A	N/A	Gutter X Slope (%)	N/A
N/A	Painted X Walk1?	No	N/A	Painted X Walk2?	No
	X Walk 1 Direction	To S		X Walk 2 Direction	To E
N/A	X Walk 1 Width (in)	N/A	N/A	X Walk 2 Width (in)	N/A
	X Walk 1 Slope (%)	0.1		X Walk 2 Slope (%)	2.0
	X Walk 1 X Slope (%)	1.1		X Walk 2 X Slope (%)	2.4

Remove & Replace Curb Ramp With Two New Directional Ramps or Equivalent.
