Access Compliance Report
Public Rights-of-Way
(Curb Ramps)

Intersection ID: 11378	Main Street: BULLARD_ST	Cross Street: WILSON_AV	Location:	SE
ADA ID: 4453512D14EA	Ramp Type: Combination1	Initial Pass/Fail: Fail	Overall Compliance: No	Severity Score: 22.5

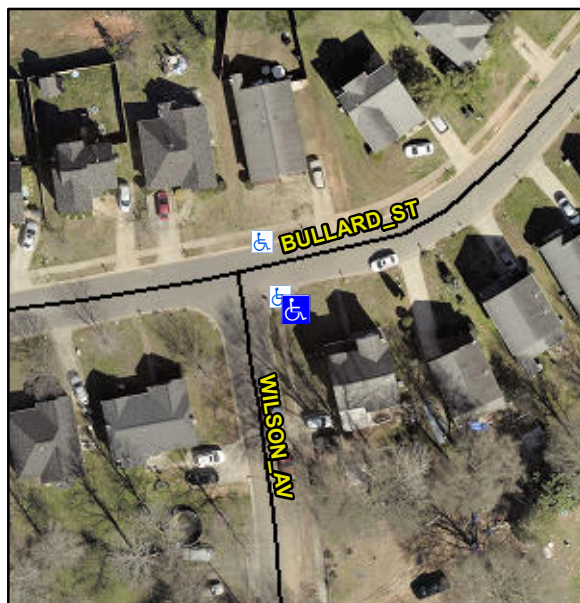
RT RP < 5%

Not Found, R304.5.1, R304.5.1, R304.2.2, R304.5.3

Compliance	Description	Data	Compliance	Description	Data
N/A	Ramp Length LT (in)	64.0	N/A	Ramp Length RT (in)	24.0
No	Ramp Width LT (in)	46.0	No	Ramp Width RT (in)	47.0
Yes	Ramp Slope LT (%)	6.3	Yes	Ramp Slope RT (%)	4.8
No	Ramp XSlope LT (%)	3.1	No	Ramp XSlope RT (%)	2.4
N/A	Ramp Length (in)	48.0	No	Ramp Slope (%)	8.5
No	Ramp Width (in)	38.5	Yes	Ramp XSlope (%)	0.9
N/A	Flare Type LT	N/A	N/A	Flare Type RT	N/A
N/A	Flare Slope LT (%)	N/A	N/A	Flare Slope RT (%)	N/A
N/A	Flare Traversable LT?	N/A	N/A	Flare Traversable RT?	N/A
N/A	Landing Length (in)	N/A	N/A	DWS Provided?	N/A
N/A	Landing Width (in)	N/A	N/A	DWS Contrast?	N/A
N/A	Landing Slope (%)	N/A	N/A	DWS Length (in)	N/A
N/A	Landing X Slope (%)	N/A	N/A	DWS Full Width?	N/A
N/A	Landing Curb? (Y/N)	N/A	N/A	DWS Offset (in)	N/A
N/A	Shared Landing?	N/A			
N/A	Gutter Ponding?	N/A	N/A	Gutter Slope (%)	N/A
N/A	Gutter Lip Ht (in)	N/A	N/A	Gutter X Slope (%)	N/A
N/A	Painted X Walk1?	No	N/A	Painted X Walk2?	N/A

Remove & Replace Entire Ramp.
