Access Compliance Report
Public Rights-of-Way
(Curb Ramps)

Intersection ID: 11619	**Main Street:** E_15TH_ST	**Cross Street:** N_CALDWELL_ST	**Location:** N
ADA ID: 45370D5E4919	**Ramp Type:** PerpDiag	**Initial Pass/Fail:** Fail	**Overall Compliance:** No	**Severity Score:** 21.25

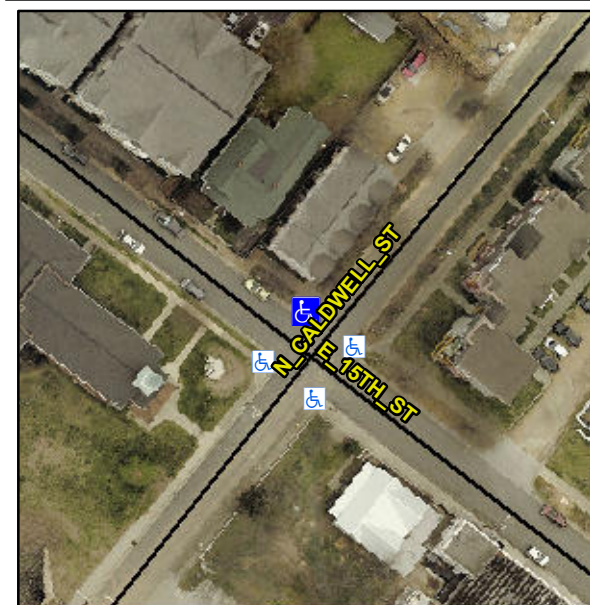
R304.5.1, R304.2.2

Compliance	Description	Data	Compliance	Description	Data
N/A	Ramp Length (in)	76.0	No	Ramp Slope (%)	8.6
No	Ramp Width (in)	41.0	Yes	Ramp XSlope (%)	1.3
N/A	Flare Type LT	N/A	N/A	Flare Type RT	N/A
N/A	Flare Slope LT (%)	N/A	N/A	Flare Slope RT (%)	N/A
N/A	Flare Traversable LT?	N/A	N/A	Flare Traversable RT?	N/A
N/A	Landing Length (in)	N/A	N/A	DWS Provided?	N/A
N/A	Landing Width (in)	N/A	N/A	DWS Contrast?	N/A
N/A	Landing Slope (%)	N/A	N/A	DWS Length (in)	N/A
N/A	Landing X Slope (%)	N/A	N/A	DWS Full Width?	N/A
N/A	Landing Curb? (Y/N)	N/A	N/A	DWS Offset (in)	N/A
N/A	Shared Landing?	N/A			
N/A	Gutter Ponding?	N/A	N/A	Gutter Slope (%)	N/A
N/A	Gutter Lip Ht (in)	1.5	N/A	Gutter X Slope (%)	N/A
N/A	Painted X Walk1?	No	N/A	Painted X Walk2?	No
	X Walk 1 Direction	To SW		X Walk 2 Direction	To SE
N/A	X Walk 1 Width (in)	N/A	N/A	X Walk 2 Width (in)	N/A
	X Walk 1 Slope (%)	2.8		X Walk 2 Slope (%)	4.6
	X Walk 1 X Slope (%)	3.1		X Walk 2 X Slope (%)	1.6

Remove & Replace Curb Ramp With Two New Directional Ramps or Equivalent.

Total Cost: **$ 3200.00**
