Access Compliance Report

# Public Rights-of-Way
(Curb Ramps)

Intersection ID: 2419	**Main Street:** LAUREL_RUN_DR	**Cross Street:** WILDBROOK_DR	**Location:** S
ADA ID: 45EEDCABD631	**Ramp Type:** PerpDiag	**Initial Pass/Fail:** Fail	**Overall Compliance:** No	**Severity Score:** 10

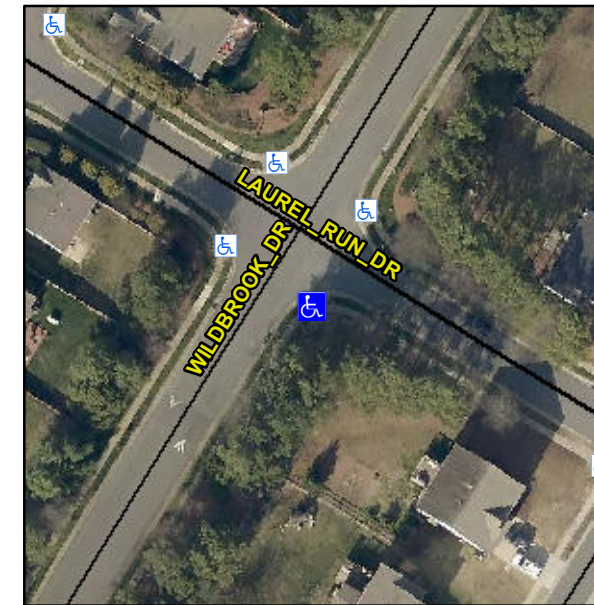
Not Found, R304.5.1, R304.5.3

Compliance	Description	Data	Compliance	Description	Data
N/A	Ramp Length (in)	62.0	Yes	Ramp Slope (%)	5.3
No	Ramp Width (in)	47.0	No	Ramp XSlope (%)	2.7
N/A	Flare Type LT	N/A	N/A	Flare Type RT	N/A
N/A	Flare Slope LT (%)	N/A	N/A	Flare Slope RT (%)	N/A
N/A	Flare Traversable LT?	N/A	N/A	Flare Traversable RT?	N/A
N/A	Landing Length (in)	N/A	N/A	DWS Provided?	N/A
N/A	Landing Width (in)	N/A	N/A	DWS Contrast?	N/A
N/A	Landing Slope (%)	N/A	N/A	DWS Length (in)	N/A
N/A	Landing X Slope (%)	N/A	N/A	DWS Full Width?	N/A
N/A	Landing Curb? (Y/N)	N/A	N/A	DWS Offset (in)	N/A
N/A	Shared Landing?	N/A			
N/A	Gutter Ponding?	N/A	N/A	Gutter Slope (%)	N/A
N/A	Gutter Lip Ht (in)	N/A	N/A	Gutter X Slope (%)	N/A
N/A	Painted X Walk1?	No	N/A	Painted X Walk2?	No
	X Walk 1 Direction	To NE		X Walk 2 Direction	To NW
N/A	X Walk 1 Width (in)	N/A	N/A	X Walk 2 Width (in)	N/A
	X Walk 1 Slope (%)	0.6		X Walk 2 Slope (%)	2.5
	X Walk 1 X Slope (%)	1.4		X Walk 2 X Slope (%)	2.7

Remove & Replace Curb Ramp With Two New Directional Ramps or Equivalent.
