Access Compliance Report

# Public Rights-of-Way
(Curb Ramps)

Intersection ID: 14383	Main Street: CLEVELAND_AV	Cross Street: E_TREMONT_AV	Location: S
ADA ID: 469D4D6887E2	Ramp Type: PerpDiag	Initial Pass/Fail: Fail	Overall Compliance: No	Severity Score: 12.5

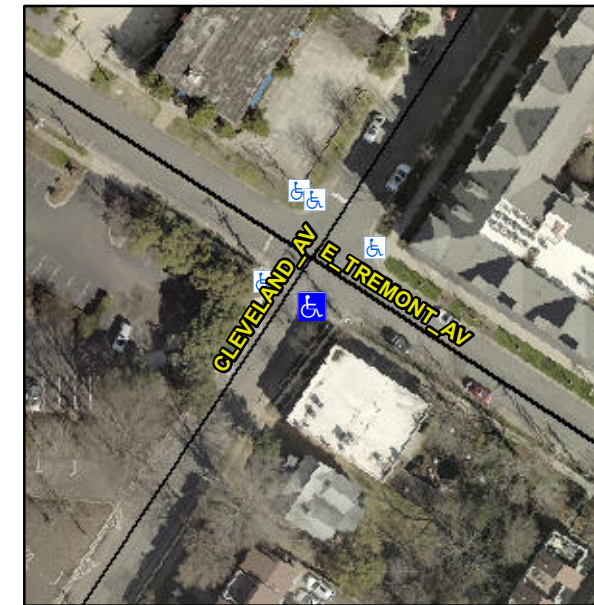
Not Found, R304.5.3

Compliance	Description	Data	Compliance	Description	Data
N/A	Ramp Length (in)	50.0	Yes	Ramp Slope (%)	6.7
Yes	Ramp Width (in)	48.0	No	Ramp XSlope (%)	5.2
N/A	Flare Type LT	N/A	N/A	Flare Type RT	N/A
N/A	Flare Slope LT (%)	N/A	N/A	Flare Slope RT (%)	N/A
N/A	Flare Traversable LT?	N/A	N/A	Flare Traversable RT?	N/A
N/A	Landing Length (in)	N/A	N/A	DWS Provided?	N/A
N/A	Landing Width (in)	N/A	N/A	DWS Contrast?	N/A
N/A	Landing Slope (%)	N/A	N/A	DWS Length (in)	N/A
N/A	Landing X Slope (%)	N/A	N/A	DWS Full Width?	N/A
N/A	Landing Curb? (Y/N)	N/A	N/A	DWS Offset (in)	N/A
N/A	Shared Landing?	N/A			
N/A	Gutter Ponding?	N/A	N/A	Gutter Slope (%)	N/A
N/A	Gutter Lip Ht (in)	N/A	N/A	Gutter X Slope (%)	N/A
N/A	Painted X Walk1?	No	N/A	Painted X Walk2?	No
	X Walk 1 Direction	To NE		X Walk 2 Direction	To NW
N/A	X Walk 1 Width (in)	N/A	N/A	X Walk 2 Width (in)	N/A
	X Walk 1 Slope (%)	1.9		X Walk 2 Slope (%)	6.8
	X Walk 1 X Slope (%)	3.4		X Walk 2 X Slope (%)	0.9

Remove & Replace Curb Ramp With Two New Directional Ramps or Equivalent.
