Access Compliance Report
Public Rights-of-Way
(Curb Ramps)

Intersection ID: 48198	Main Street: RIVERGATE_PY	Cross Street: S_TRYON_ST	Location:	NW
ADA ID: 46CBD287C2A0	Ramp Type: Perp	Initial Pass/Fail: Pass	Overall Compliance: No	Severity Score: 10.25

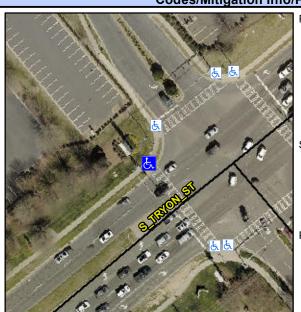
Not Found, R304.5.3, R304.2.1, R304.2.2-Perp, R304.3.2-Para

Compliance	Description	Data	Compliance	Description	Data
N/A	Ramp Length (in)	132.0	Yes	Ramp Slope (%)	6.4
Yes	Ramp Width (in)	48.0	No	Ramp XSlope (%)	4.9
N/A	Flare Type LT	Sloped	N/A	Flare Type RT	N/A
N/A	Flare Slope LT (%)	10.3	N/A	Flare Slope RT (%)	3.6
N/A	Flare Traversable LT?	No	N/A	Flare Traversable RT?	No
No	Landing Length (in)	N/A	Yes	DWS Provided?	Yes
No	Landing Width (in)	N/A	Yes	DWS Contrast?	Yes
No	Landing Slope (%)	N/A	Yes	DWS Length (in)	24.5
No	Landing X Slope (%)	N/A	Yes	DWS Full Width?	Yes
N/A	Landing Curb? (Y/N)	No	Yes	DWS Offset (in)	0.0
N/A	Shared Landing?	No			
Yes	Gutter Ponding?	No	Yes	Gutter Slope (%)	1.1
Yes	Gutter Lip Ht (in)	0.0	No	Gutter X Slope (%)	2.6
N/A	Painted X Walk1?	Yes	N/A	Painted X Walk2?	N/A
	X Walk 1 Direction	To SE		X Walk 2 Direction	N/A
N/A	X Walk 1 Width (in)	110.0	N/A	X Walk 2 Width (in)	N/A
	X Walk 1 Slope (%)	1.2		X Walk 2 Slope (%)	N/A
	X Walk 1 X Slope (%)	2.0		X Walk 2 X Slope (%)	N/A

Yes	Ramp inside XWalk1?	Yes	N/A	Ramp inside XWalk2?	N/A
	Road Slope (%)	N/A	N/A	Clear Space?	Yes
	Road X Slope (%)	N/A	N/A	Clear Space to XWalk (in)	N/A
Yes	Any Obstructions?	No	Yes	Storm Grate/Utility Hazard?	No
	Obstruction Type			Storm Grate/Utility Type	
		N/A			N/A
			Yes	Surface Condition? (G/P)	Good

Remove & Replace Entire Ramp.
Remove & Replace Gutter.
