Access Compliance Report
Public Rights-of-Way
(Curb Ramps)

Intersection ID: 3762	Main Street: MERION_HILLS_CT	Cross Street: TRADITION_VIEW_DR	Location:	SW
ADA ID: 4727F31555F0	Ramp Type: Perp	Initial Pass/Fail: Fail	Overall Compliance: No	Severity Score: 0

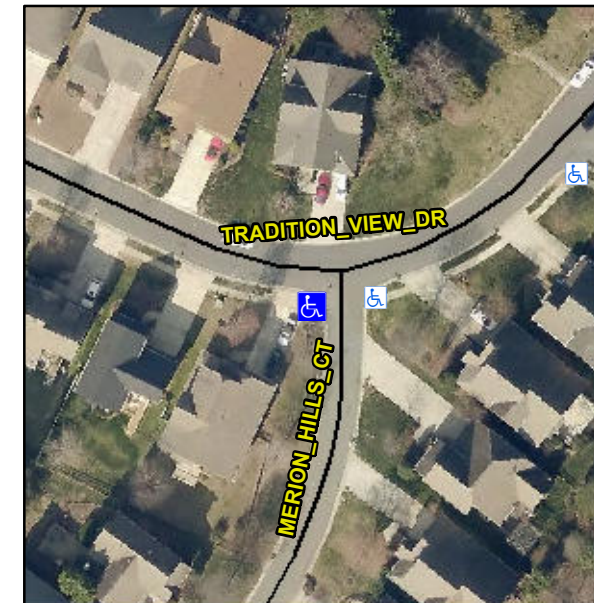
Compliance	Description	Data	Compliance	Description	Data
N/A	Ramp Length (in)	46.0	Yes	Ramp Slope (%)	7.0
Yes	Ramp Width (in)	48.0	Yes	Ramp XSlope (%)	0.6
N/A	Flare Type LT	N/A	N/A	Flare Type RT	N/A
N/A	Flare Slope LT (%)	N/A	N/A	Flare Slope RT (%)	N/A
N/A	Flare Traversable LT?	N/A	N/A	Flare Traversable RT?	N/A
N/A	Landing Length (in)	N/A	N/A	DWS Provided?	N/A
N/A	Landing Width (in)	N/A	N/A	DWS Contrast?	N/A
N/A	Landing Slope (%)	N/A	N/A	DWS Length (in)	N/A
N/A	Landing X Slope (%)	N/A	N/A	DWS Full Width?	N/A
N/A	Landing Curb? (Y/N)	N/A	N/A	DWS Offset (in)	N/A
N/A	Shared Landing?	N/A			
N/A	Gutter Ponding?	N/A	N/A	Gutter Slope (%)	N/A
N/A	Gutter Lip Ht (in)	N/A	N/A	Gutter X Slope (%)	N/A
N/A	Painted X Walk1?	No	N/A	Painted X Walk2?	N/A
	X Walk 1 Direction	To E		X Walk 2 Direction	N/A
N/A	X Walk 1 Width (in)	N/A	N/A	X Walk 2 Width (in)	N/A
	X Walk 1 Slope (%)	5.7		X Walk 2 Slope (%)	N/A
	X Walk 1 X Slope (%)	1.2		X Walk 2 X Slope (%)	N/A

N/A	Ramp inside XWalk1?	N/A	N/A	Ramp inside XWalk2?	N/A
	Road Slope (%)	N/A	N/A	Clear Space?	N/A
	Road X Slope (%)	N/A	N/A	Clear Space to XWalk (in)	N/A
N/A	Any Obstructions?	N/A	N/A	Storm Grate/Utility Hazard?	N/A
	Obstruction Type			Storm Grate/Utility Type	
N/A					N/A
			Yes	Surface Condition? (G/P)	Good

Remove & Replace Entire Ramp.
