# Access Compliance Report
Public Rights-of-Way
(Curb Ramps)

Intersection ID: 10024872	Main Street: DEWITT_LN	Cross Street: N/A	Location:	NE
ADA ID: 479D786AC78F	Ramp Type: PerpDiag	Initial Pass/Fail: Fail	Overall Compliance: No	Severity Score: 10

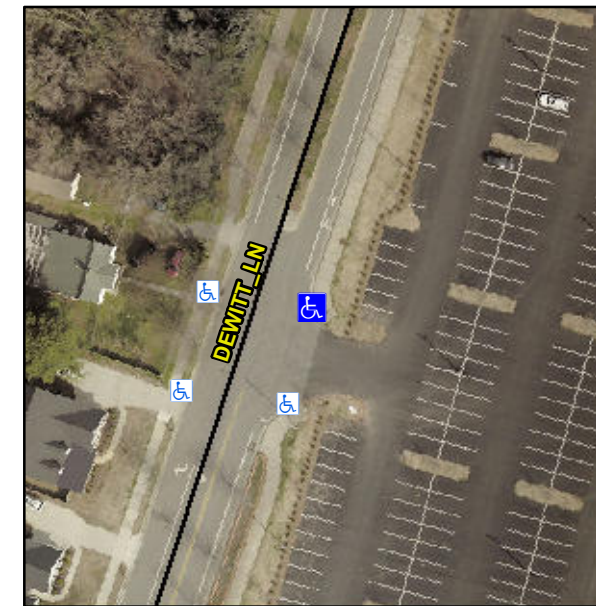
R304.5.1, R304.5.3

Compliance	Description	Data	Compliance	Description	Data
N/A	Ramp Length (in)	95.0	Yes	Ramp Slope (%)	5.4
No	Ramp Width (in)	47.0	No	Ramp XSlope (%)	3.8
N/A	Flare Type LT	N/A	N/A	Flare Type RT	N/A
N/A	Flare Slope LT (%)	N/A	N/A	Flare Slope RT (%)	N/A
N/A	Flare Traversable LT?	N/A	N/A	Flare Traversable RT?	N/A
N/A	Landing Length (in)	N/A	N/A	DWS Provided?	N/A
N/A	Landing Width (in)	N/A	N/A	DWS Contrast?	N/A
N/A	Landing Slope (%)	N/A	N/A	DWS Length (in)	N/A
N/A	Landing X Slope (%)	N/A	N/A	DWS Full Width?	N/A
N/A	Landing Curb? (Y/N)	N/A	N/A	DWS Offset (in)	N/A
N/A	Shared Landing?	N/A			
N/A	Gutter Ponding?	N/A	N/A	Gutter Slope (%)	N/A
N/A	Gutter Lip Ht (in)	N/A	N/A	Gutter X Slope (%)	N/A
N/A	Painted X Walk1?	No	N/A	Painted X Walk2?	No
	X Walk 1 Direction	To NW		X Walk 2 Direction	To SW
N/A	X Walk 1 Width (in)	N/A	N/A	X Walk 2 Width (in)	N/A
	X Walk 1 Slope (%)	4.7		X Walk 2 Slope (%)	1.1
	X Walk 1 X Slope (%)	2.8		X Walk 2 X Slope (%)	6.6

Remove & Replace Curb Ramp With Two New Directional Ramps or Equivalent.
