Access Compliance Report
Public Rights-of-Way
(Curb Ramps)

Intersection ID: 14018 **Main Street:** BAY_ST **Cross Street:** WESTOVER_ST **Location:** E

ADA ID: 47E008610F14 **Ramp Type:** Perp **Initial Pass/Fail:** Fail **Overall Compliance:** No **Severity Score:** 12.5

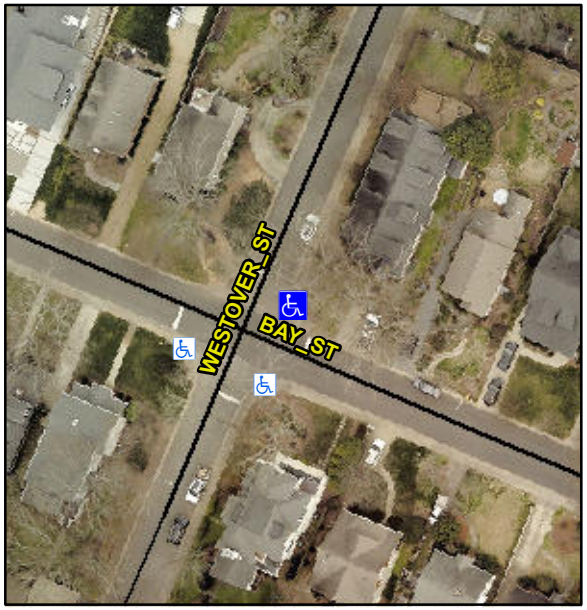
Not Found, R304.2.2

Compliance	Description	Data	Compliance	Description	Data
N/A	Ramp Length (in)	60.0	No	Ramp Slope (%)	9.2
Yes	Ramp Width (in)	54.0	Yes	Ramp XSlope (%)	1.7
N/A	Flare Type LT	N/A	N/A	Flare Type RT	N/A
N/A	Flare Slope LT (%)	N/A	N/A	Flare Slope RT (%)	N/A
N/A	Flare Traversable LT?	N/A	N/A	Flare Traversable RT?	N/A
N/A	Landing Length (in)	N/A	N/A	DWS Provided?	N/A
N/A	Landing Width (in)	N/A	N/A	DWS Contrast?	N/A
N/A	Landing Slope (%)	N/A	N/A	DWS Length (in)	N/A
N/A	Landing X Slope (%)	N/A	N/A	DWS Full Width?	N/A
N/A	Landing Curb? (Y/N)	N/A	N/A	DWS Offset (in)	N/A
N/A	Shared Landing?	N/A			
N/A	Gutter Ponding?	Yes	N/A	Gutter Slope (%)	N/A
N/A	Gutter Lip Ht (in)	N/A	N/A	Gutter X Slope (%)	N/A
N/A	Painted X Walk1?	No	N/A	Painted X Walk2?	N/A
	X Walk 1 Direction	To S		X Walk 2 Direction	N/A
N/A	X Walk 1 Width (in)	N/A	N/A	X Walk 2 Width (in)	N/A
	X Walk 1 Slope (%)	6.3		X Walk 2 Slope (%)	N/A
	X Walk 1 X Slope (%)	3.0		X Walk 2 X Slope (%)	N/A

Remove & Replace Entire Ramp.
